CRACKING IN PRECAST, PRESTRESSED DECK PLANKS IN TWO RTA BRIDGES: CAUSES OF CRACKING, CONCRETE CHARACTERISTICS AND REHABILITATION OPTIONS

*A. Shayan

ARRB Transport Research Ltd, Victoria, Australia. Howard Morris, Bridge Durability and
Maintenance, Roads and Traffic Authority of NSW, New South Wales

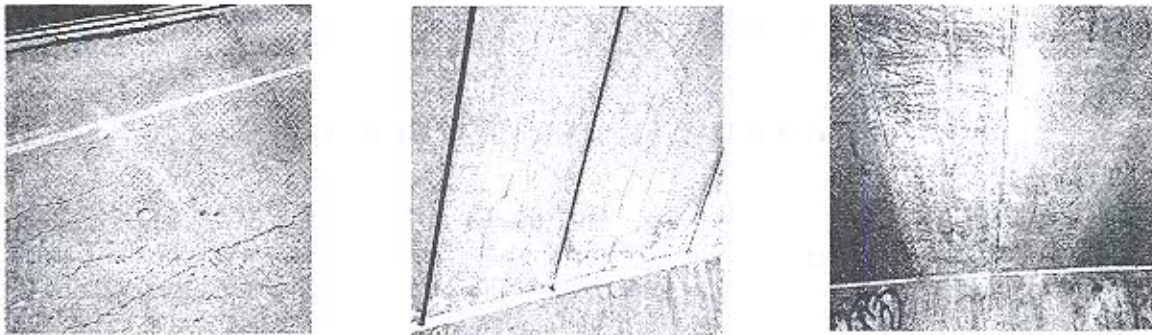
Figure 3 Cracking of the wearing course concrete (top) and beam plank (center) of MC bridge, and beam plank of BC bridge

In MC bridge, the soffit of many planks showed cracking which was worse at the two ends of the planks where they rest on the cross beam, and where there is more water leakage. The cracking of the wearing course concrete and the presence of joints at the cross beams may have caused enhanced AAR in the planks in these areas by allowing more water penetration to the planks. Two planks in the southernmost span were selected and two cores of 95 mm diameter drilled in each. These were designated cores M1-M4. Cores M1 and M3 were from the first plank west of the bridge centre-line and cores M2 and M4 from the second plank west of it.

A large number of the planks are affected by the AAR, and due to the method of construction their individual replacement is very difficult and costly. Considering the advanced stage of AAR, and existing potential for further expansion and cracking, strengthening of the planks using techniques such as composite fibre-epoxy bonding may not be advisable. In any case the wearing course of the deck would need major rehabilitation, including water-proofing and reconstruction. Another option may be replacement of the whole deck, which may be less expensive in the long term. The economy of each option needs to be considered before taking any remedial action.

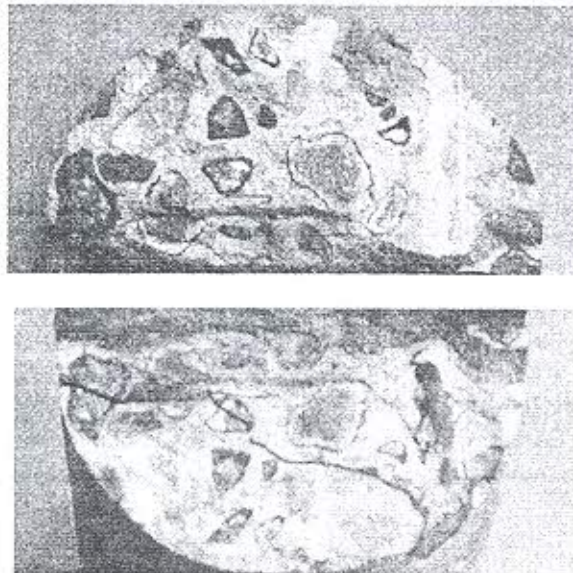
The aggregate in all the four cores from PSC planks in MC bridge is a hornfels or meta-sediment, and exhibits internal cracking, typical of AAR. Many aggregate particles show a wet-looking appearance due to AAR gel impregnation. The fracture surfaces of cores show AAR rims which vary in thickness from core to core. Some cracks and air voids appear to be filled with AAR products. Cracks about 25-30 mm deep are present in some cores. Strong AAR seems to present in the cores.

Figure 4 Fracture surfaces of core M1 (above) and two segments of core M2 (right) showing strong AAR rimming. AAR gel covers the steel/concrete interface in M2, and fills some voids in M1

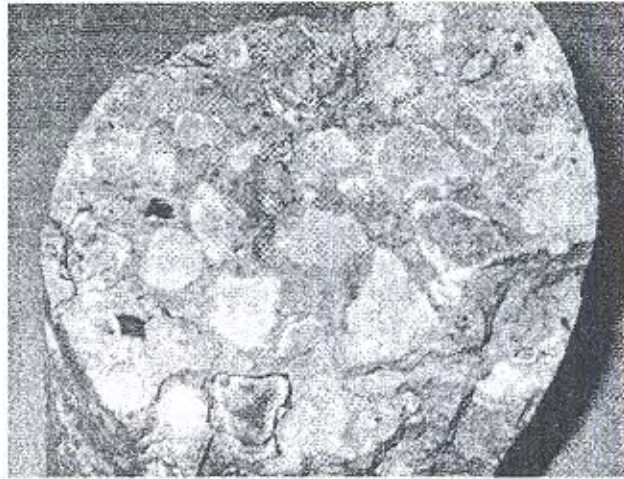
In cores from uncracked planks no unusual feature is present in the concrete. In cores from cracked planks, strong AAR rims are present at the fracture surfaces of the cores. Many aggregate pieces show internal fractures parallel to the core surface, and some are partially filled with AAR products. Strong AAR exists in the latter cores.

Figure 5 Fracture surfaces of core B1 with strong AAR rims (top), and core B3 free of AAR

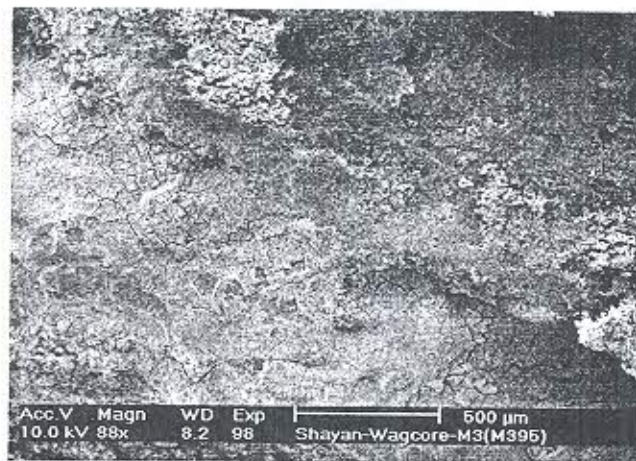
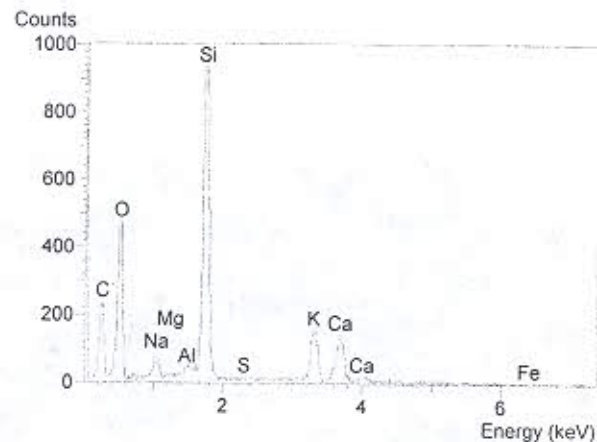
A representative example of extensive formation of AAR gel is shown in Figure 6. This gel forms within the aggregate causing expansion and stress build up that eventually causes cracking in the aggregate and mortar phases of the concrete. The gel impregnates the surrounding mortar and part of the cracks that may be formed around the aggregate. Many sites of this nature were observed in the affected concretes of both bridges. The white reaction rims on the reacted aggregate contain crystalline AAR products (Figure 7), which is indicative of advanced reaction in both concretes. Some other Na-rich phases (Figure 8) are indicative of a high alkali, Na-rich cement in the concrete.

Figure 6 AAR gel formation covering a large area around the reacted aggregate site. The composition of the cracked gel is rich in Na and Si as indicated by the EDX spectrum

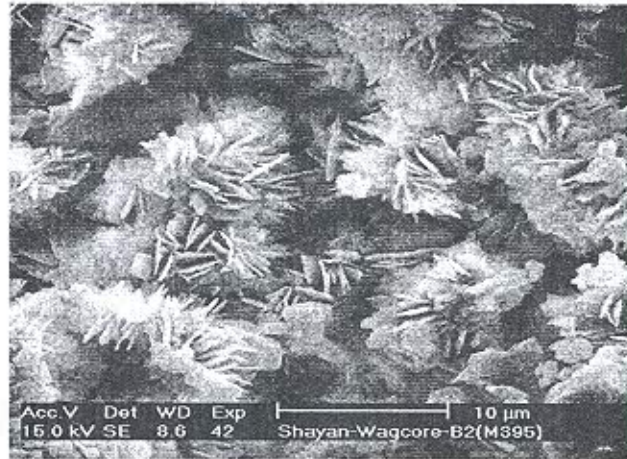
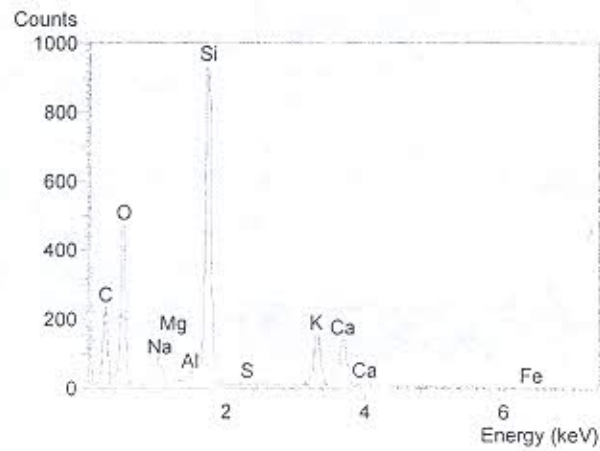
Figure 7 Crystalline (Rosette) AAR products in the white reaction rims seen within the aggregate boundaries

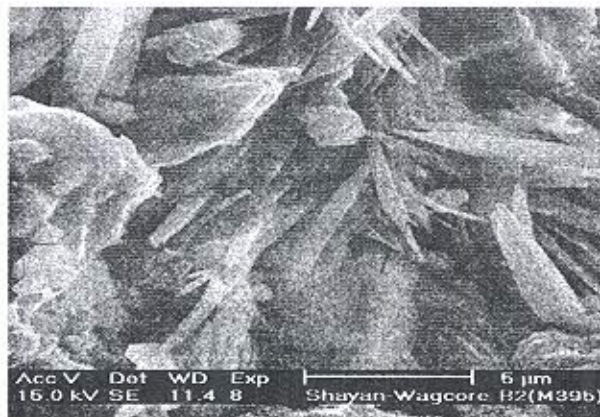
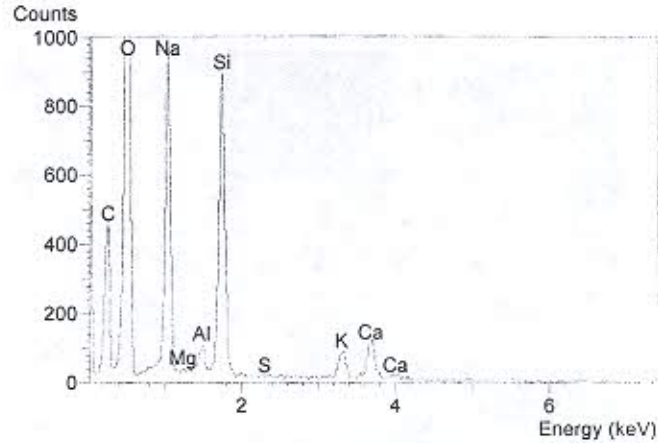
Figure 8 AAR product highly enriched in Na, indicative of high Na content in the cement

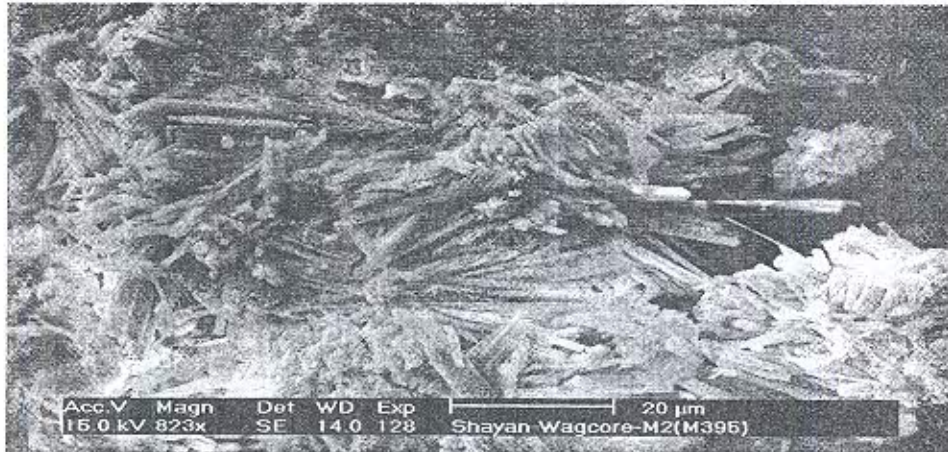
Other than the usual form of ettringite lining in some air voids, a few locations were seen in MC bridge concrete, where the form of ettringite at the cement/aggregate interface (Figure 9) may indicate expansive ettringite as judged from its radial growth at the reaction site into the interfacial paste. In BC bridge concrete, locations were seen where AAR products were associated with ettringite, as indicated by the composition of the materials seen in Figure 10. The ettringite appears to have been formed at a later stage than the AAR gel in cracks at the aggregate interface, as seen in Figure 11, where ettringite crystals are shown below the layer of AAR gel at the aggregate surface. Figure 12 shows another site of ettringite formation where it could indicate some contribution to concrete expansion, by its compact form that has filled a gap at cement/aggregate interface. Such locations were far less frequent than the AAR sites, in both bridges, and it appears that AAR is by far the main cause of the observed cracking.

Figure 9 Expansive ettringite formed at the cement/aggregate interface of MC concrete

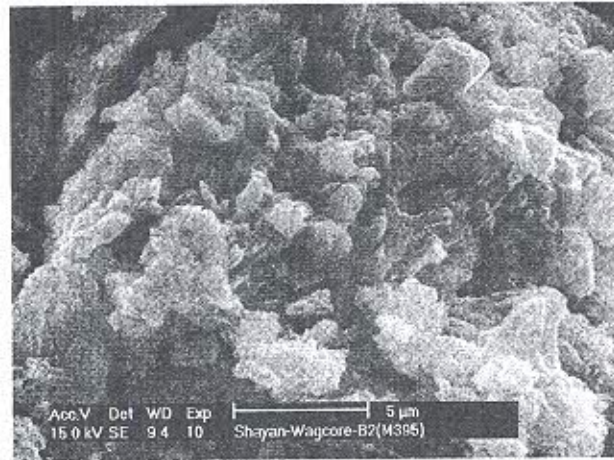
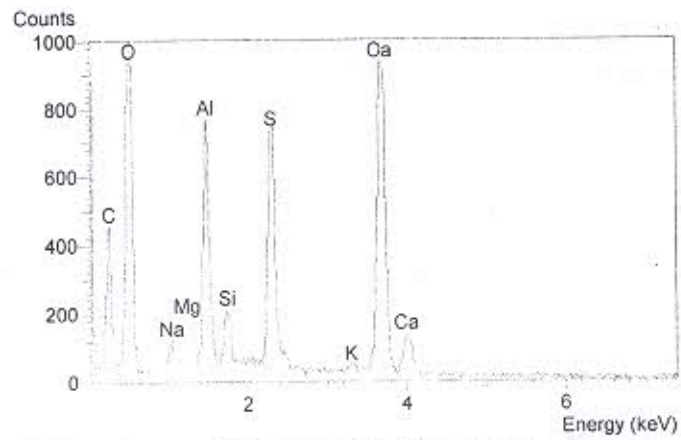
Figure 10 Mixture of AAR and ettringite

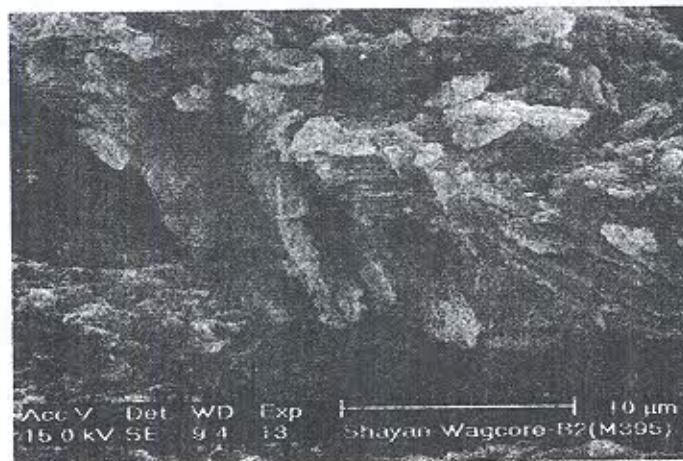
Figure 11 Etringite crystals forming under a layer of AAR gel at the aggregate surface, indicating its later formation than the AAR products

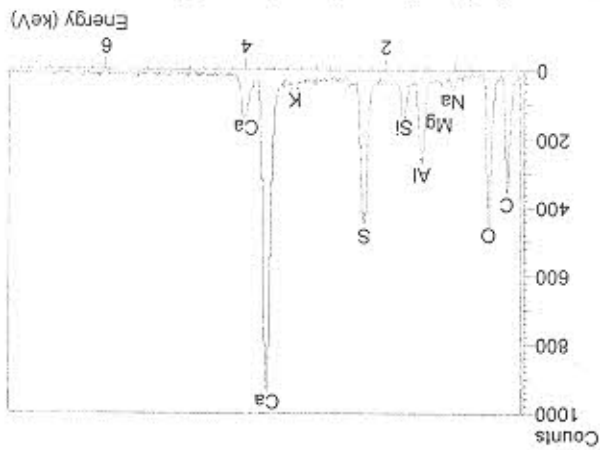
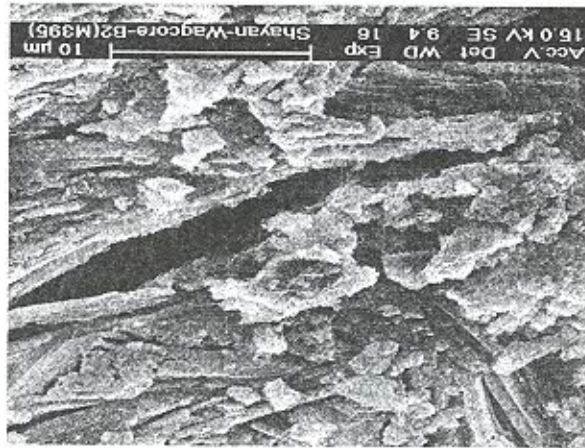
Figure 12 Etringite layer found at aggregate interface, and mixed with small amounts of AAR gel

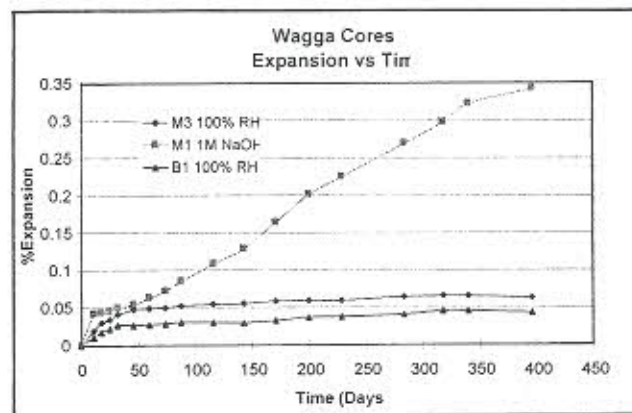
Figure 13 shows the expansion curves obtained under the two storage conditions. Core M1 in 1M NaOH, 40°C continues to expand, indicating the presence of reactive components, and will continue until the maximum expansion potential is reached. Expansion of core M3 under 100% RH 40°C , has been slower and smaller, as expected, and has reached 0.07% at 340 days of storage, of which around 0.04% could be due to water absorption rather than AAR expansion. Assuming 0.03% residual expansion, each affected plank (600 mm wide) will expand laterally by 0.24 mm which could be accommodated by the sealed gap between the planks. However, this could cause further longitudinal cracking in the planks. Due to the prestressing effects, the longitudinal expansion may be less than the lateral expansion.

Figure 13 Expansion curves for core segments under the conditions indicated

Expansion of core B1 has reached 0.045% at 340 days of storage, of which 0.025% is probably due to water absorption, and the remaining 0.02% is the residual AAR expansion. This lower expansion compared to core M3 is probably because the BC plank has already undergone more extensive AAR than the MC plank. The expected lateral expansion of the plank (600 mm wide) of 0.12 mm could also be accommodated by the gap between the planks, otherwise the movement across the deck would be 2.0 mm if all the planks expand to this level. Actually, some of the planks are not expansive. These movements should be taken into account in any rehabilitation program.
