SEISMIC BEHAVIOUR OF EXTERIOR BEAM-COLUMN JOINTS WITH SQUARE SPIRAL CONFINEMENT

P. Asha ^{*a}, R. Sundararajan ^b

ABSTRACT

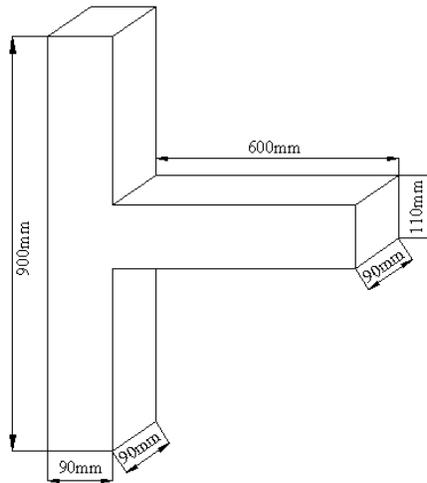
Figure 1. Overall dimensions of test specimens

The test specimens were 1/4 scale models of typical exterior beam-column joints made up of a single column with one beam in the longitudinal direction. All specimens were cut at mid-height of supporting column and at midspan of beams, which were the assumed points of inflection. Figure 1 shows a sketch of test specimens with overall dimensions.

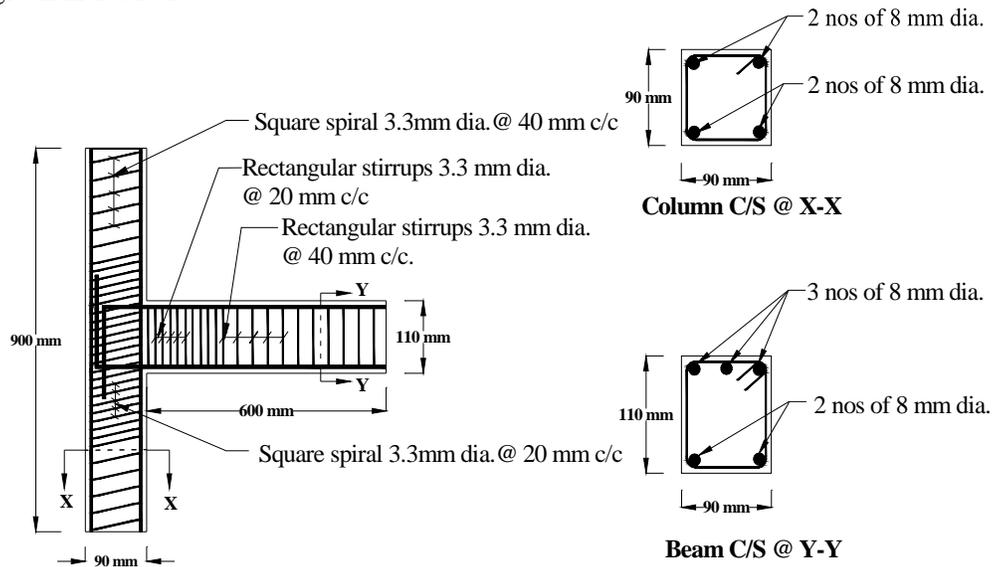
Figure 2. Reinforcement details of SS

The specimens were designed for both gravity loads and earthquake forces. The earthquake forces were calculated for Zone III as per IS 1893-(Part 1) 2002. The specimens were designed for seismic forces and detailed as per IS 13920-1993. The first specimen is SS (Figure 2) which had Square Spiral confinement in the joint which was extended into column. Five other reinforcement detailing schemes were incorporated in SS and the specimens are designated as SS1, SS2, SS3, SS4 and SS5 (Figure 3). Hence all the six specimens were having same dimensions and same shape of confinement (square spirals) with variance in the reinforcement detailing. The objective of this investigation is to improve the seismic performance of exterior beam-column joints through combined effect of square spiral confinement and five different types of reinforcement detailing.

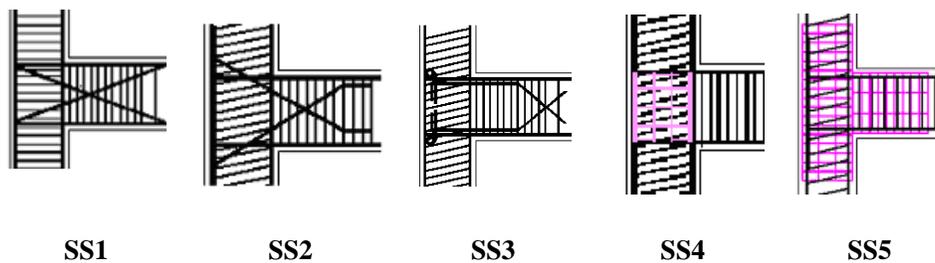
Figure 3. Various schemes of reinforcement detailing

SS1 indicates specimen having longitudinal beam bars with inclined anchorage and SS2 had four inclined bars that extend from column to beam, two from the column portion above the joint and two from the column portion below the joint. The specimen SS3 was provided

with four supplementary bars in beam, two at top and two at bottom which were intersected to form 'X' shape. The beam main bars in SS3 were provided with round hook anchorage. SS4 had box-shaped welded wire mesh in the joint region alone as additional confinement whereas SS5 had welded wire mesh in column and beam as additional main and transverse reinforcement. The spacing of transverse reinforcement in joint and throughout in beam and column was maintained as $D/2$ in SS5 where 'D' is the overall depth of member. Welded wire mesh used was made up of 2.2mm diameter with spacing 25.4mm c/c. In SS1, SS2, SS3 and SS4 the joint and areas in beam upto a distance of $2D$ were provided with transverse reinforcement with $D/4$ spacing as that of SS as per recommendations of IS 13920-1993. The transverse reinforcement in column was spaced at $D/4$ to a height of l_o (l_o is the length of member over which special confinement reinforcement is to be provided) above and below the level of joint in the column which was calculated as 180 mm according to IS 13920. The percentage of column, beam and joint reinforcement of the test specimens is given in Table 1.

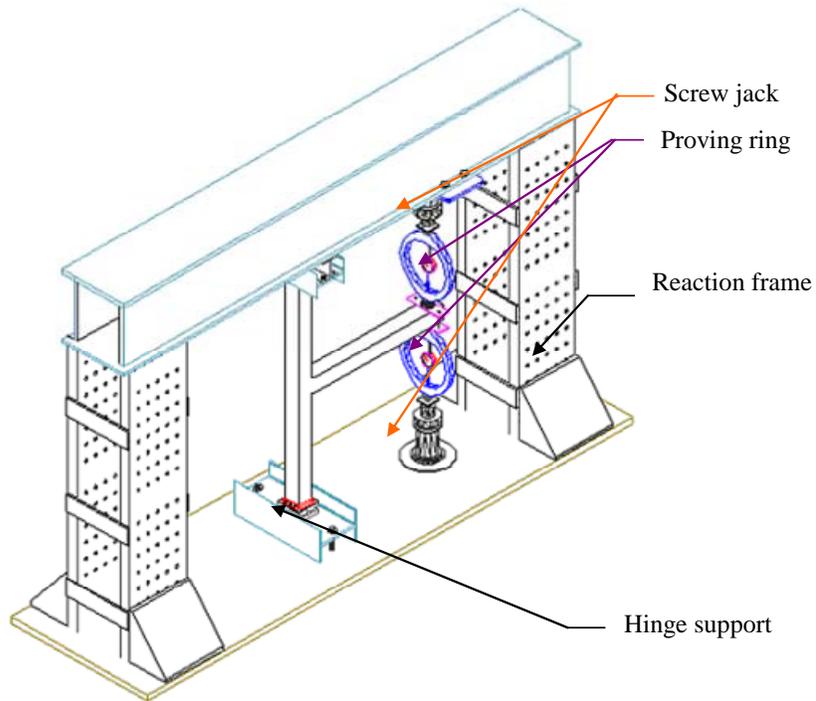
Figure 4. Schematic diagram of test setup

The specimens were tested with the column portion vertical in a 100 ton reinforced concrete reaction frame as shown in Figure 4. No axial compression was applied to the columns in order to evaluate a worst-case scenario for the joint core. The column ends were attached to pivot assemblies at both ends to provide hinge conditions to simulate point of inflexion at both sides of the column. Screw jacks were placed on top and bottom of beam by which displacement controlled loading was applied. Proving rings were attached to screw jacks which were used to measure the load applied to the beam end. The deflections and rotations of beam were measured by dial gauges. The strain was measured from steel rods which were welded to beam reinforcement by Whittemore Strain Gauge.

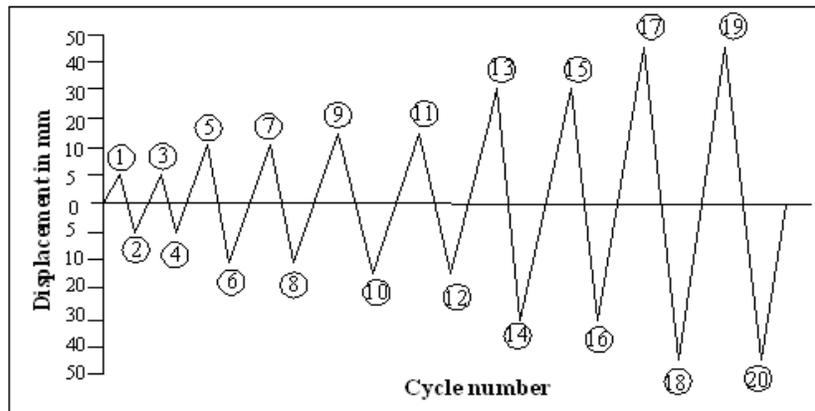
Figure 5. Cyclic displacement loading history applied on the test specimens

The loading programme consisted of a simple history of reversed symmetric displacement of increasing amplitudes 5mm, 10mm, 15mm, 30mm and 45mm as shown in Figure 5. The loading in positive direction of first 5 mm displacement cycle was numbered as "1" and the numbering was continued up to the last 45 mm displacement cycle. The two

cycles of 5 mm displacement were named as “1A”, “1B” and that of 10 mm displacement as “2A”, “2B” and so on.

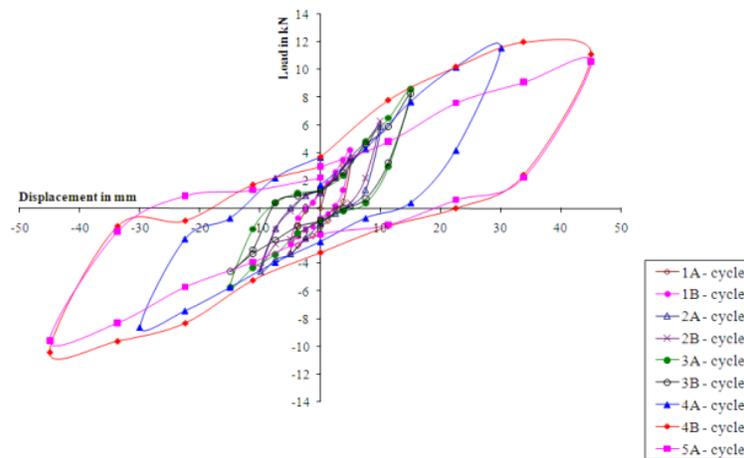
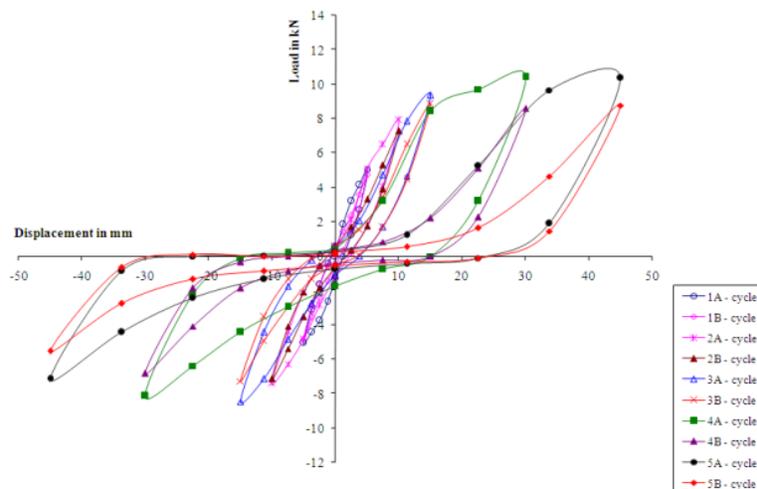
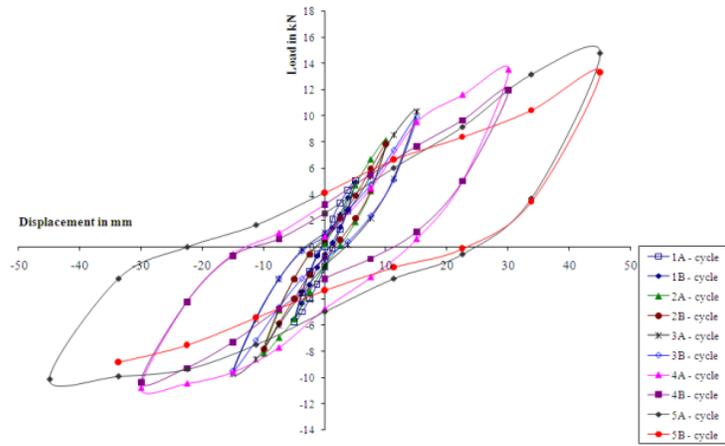
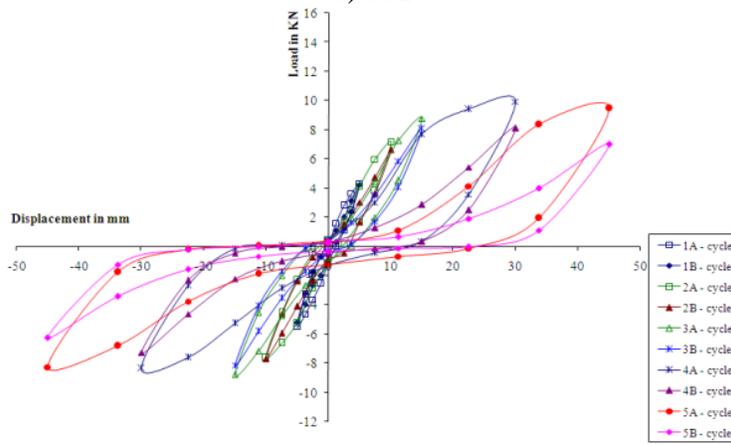
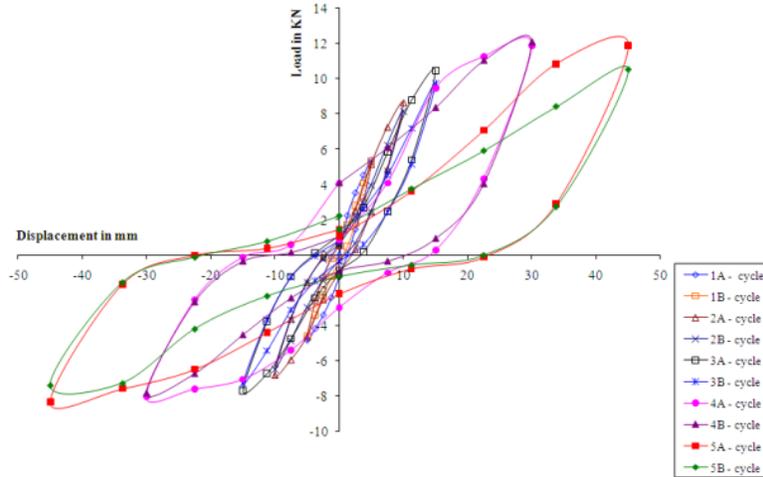
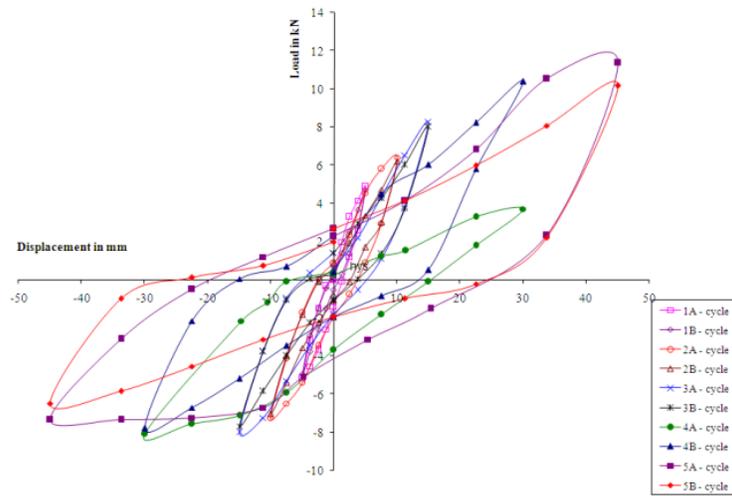
Figure 6. Lateral load-displacement hysteresis loop

From the lateral load-displacement hysteresis loops (Figures 6a to 6f) of specimens, it is observed that SS, SS2, SS4 and SS5 possessed spindle shaped curves without pinching showing SS2 with the highest load carrying capacity of 15.6kN. There was steady increase in load with every increased displacement which continued even after 30mm displacement cycles. This proved that all these specimens had not failed till the 45mm displacement cycle. SS1 and SS3 experienced severe pinching and failed due to slippage of beam and column bars passing through the joint and joint shear deterioration respectively. The experimental maximum load of SS2 was greater than the experimental maximum load of SS, SS1, SS3, SS4 and SS5 by 22%, 30%, 33%, 19% and 18% respectively.

- Spindle-shaped hysteresis loops and better load carrying capacities were observed in SS, SS2, SS4 and SS5. SS2 has the highest experimental maximum load of 15.6 kN. SS1 and SS3 experienced severe pinching in the hysteresis loops due to their low strength and stiffness.
- The percent of initial stiffness retained at 45mm displacement of SS, SS2, SS4 and SS5 was higher than SS1 and SS3. SS2 retained the highest percent (31%) of initial stiffness among all the specimens.
- SS2 dissipated the highest value of total energy of 1231 kNmm among all the specimens tested. SS1 and SS3 dissipated lower values of total energy at 45mm displacement compared to SS, SS2, SS4 and SS5.

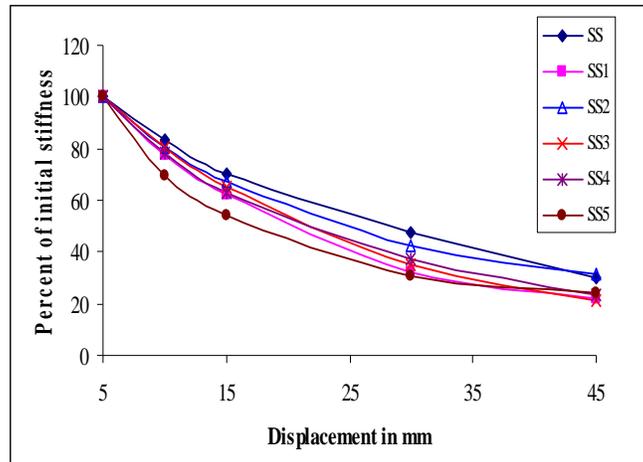
Figure 7. Percent of initial stiffness versus displacement curves

The percent of initial stiffness at the end of 45mm displacement cycle is presented in Figure 7. It is observed that SS2 retained the highest percentage of 31% of initial stiffness at the end of 45mm displacement cycle followed by SS, SS5, SS4, SS1 and SS3. The stiffness of SS, SS5, SS4, SS1 and SS3 after 45 mm displacement cycle was 30%, 24%, 23%, 22% and 21%, respectively, of their initial stiffness.

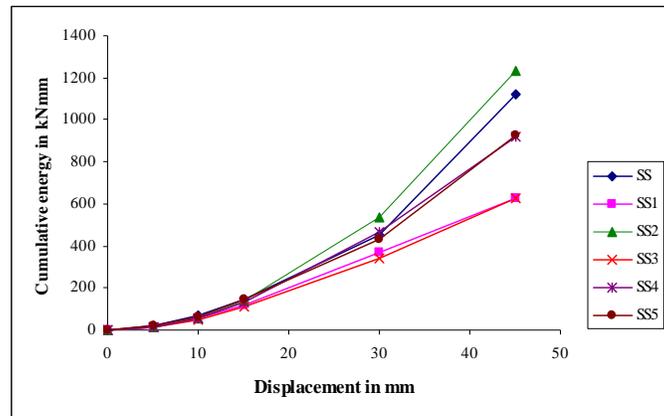
Figure 8. Cumulative energy versus displacement curves of SS series specimens

From the cumulative energy versus displacement curves of specimens with square spiral confinement plotted in Figure 8, it is seen that the specimen SS2 had the highest value of E_t of 1231.03 kNmm. E_t of SS2 was greater than E_t of SS by 9% and that of SS4 and SS5 by 25% each. The total energy dissipated by SS2 was greater than E_t of SS1 and SS3 by an equal amount of 49%.

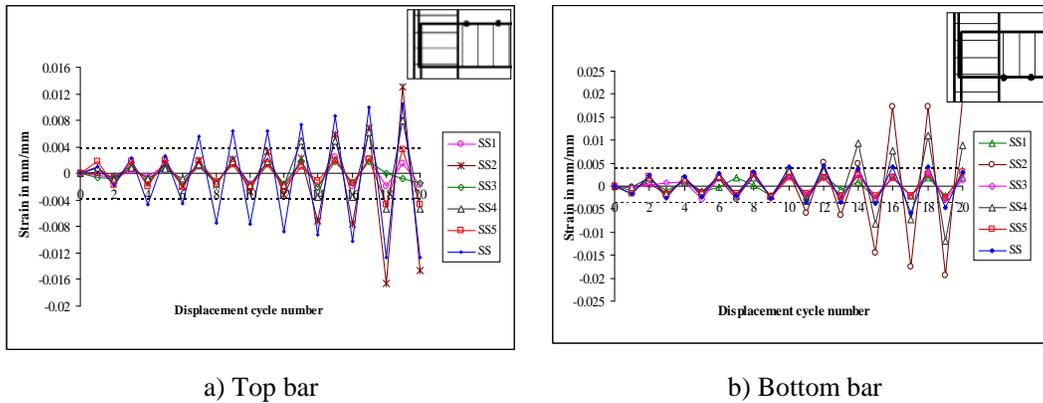
Figure 9. Comparison of strain

The strain values (Figure 9a) in beam top and bottom bar at face of column indicate that the specimens SS, SS2, SS4 and SS5 had cyclic tension and compression without slippage and yielded as the higher displacement cycles were imposed except SS1 and SS3. The beam top

bars of SS1 and SS3 showed slippage after second -30mm (cycle number 16) and first +45 mm displacement (cycle number 17) respectively. The beam bottom bar (Figure 9b) of SS1 and SS3 showed reversal of direction in strain at second +5 mm displacement (cycle number 3) and first -10 mm (cycle number 6) respectively. Because there is no continuation of such tendency in the subsequent cycles, this indicates localized slip.

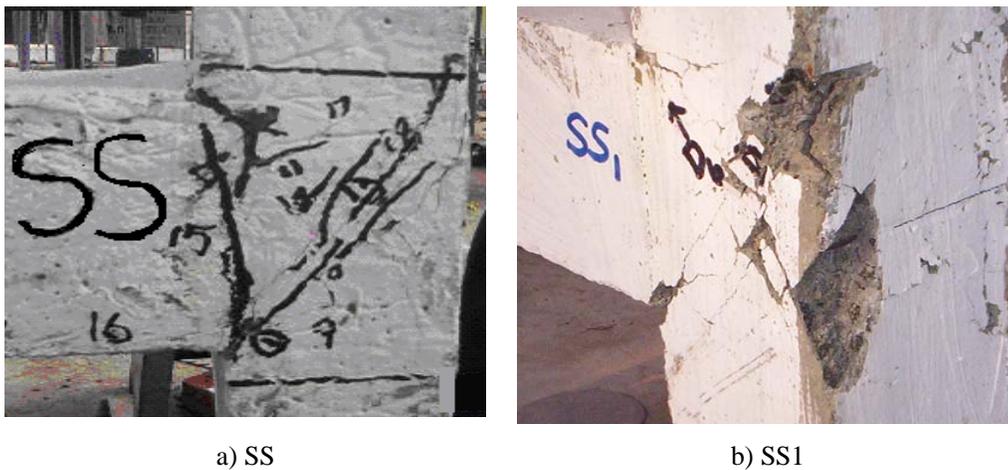
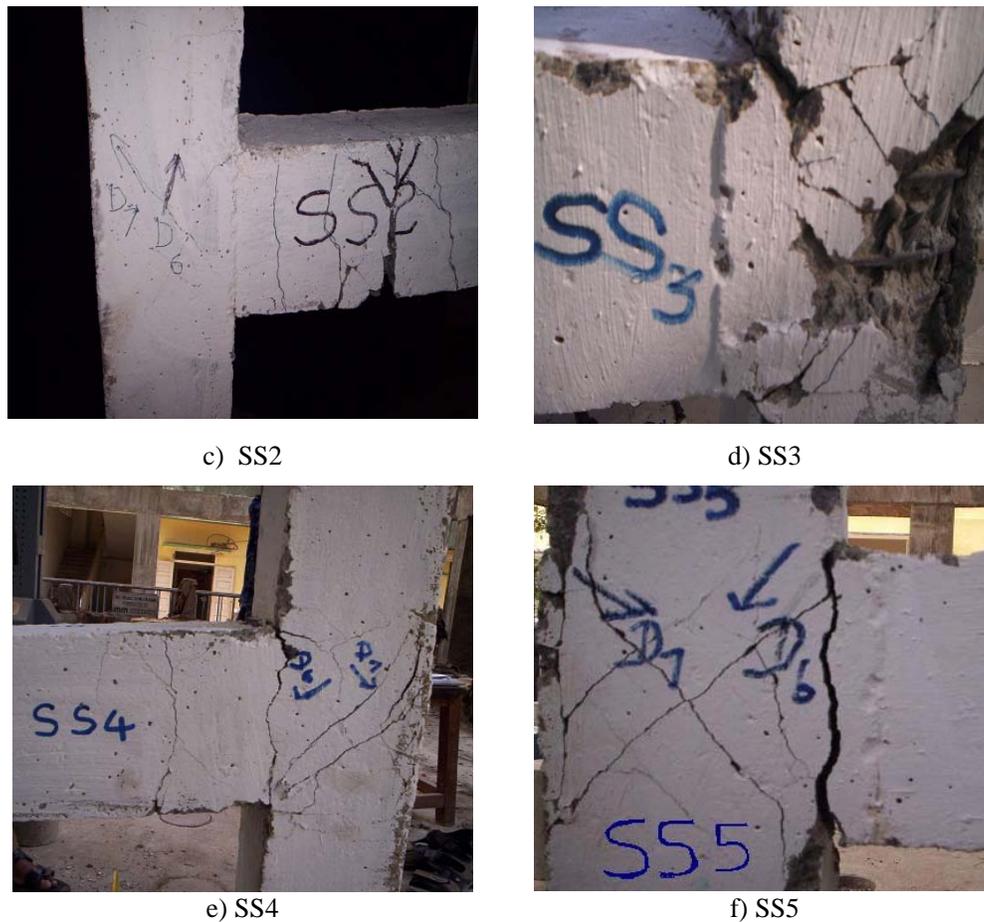
Figure 10. Crack pattern

The crack pattern and location provide a first hand insight of the behaviour of the specimen. SS, SS4 and SS5 (Figure 10a, 10e and 10f) experienced minor damage in joint region due to shear cracks with only the domination of plastic hinge at the interface region. From Figure 10 b and 10d, it may be concluded that SS1 failed due to slippage of column and beam bars and SS3 failed only due to joint shear. SS2 (Figure 10b) experienced hairline ‘X’ shaped cracks in the joint region and full depth cracks in beam region approximately at a distance of 1.5D from the face of column. This confirmed that plastic hinge formed in the beam approximately at the location where the additional inclined bars were curtailed.

- d) SS2 only had its beam rotation at a distance of $2D$ greater than the beam rotation at distance of D confirming the relocation of plastic hinge. SS, SS2, SS4 and SS5 had higher beam rotation at a distance of D than the beam rotation at a distance of $2D$.
- e) The plastic hinge formed in SS, SS2, SS4 and SS5 at the beam-column interface whereas in SS2 it was at a distance of $1.5D$ from the face of column. SS1 and SS3 experienced severe joint shear deterioration due to which the specimens failed.
- f) The beam main bars of SS, SS2, SS4 and SS5 possessed better anchorage with reduced bond deterioration. The beam bars in SS1 and SS3 experienced severe bond deterioration resulting in slip of the bars with the surrounding concrete.
