## A NEW METHOD FOR IMPROVING DUCTILITY IN EXISTING RC ORDINARY MOMENT RESISTING FRAMES USING FRPS

### ABSTRACT

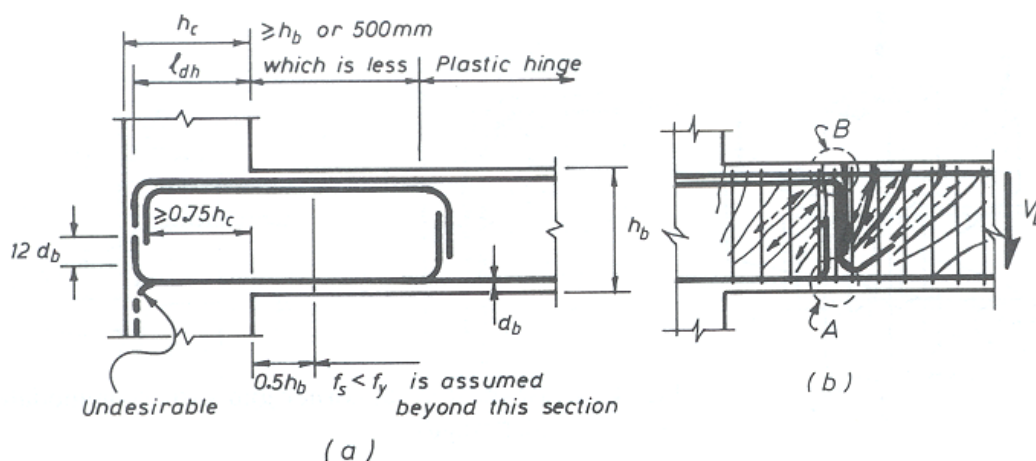
Figure 3. Potential plastic hinge relocated from the face of a column [3]

There are several methods to achieve this. One possibility is to detail the reinforcement as is shown in Figure 3 (a). In this way stresses in the reinforcement do not exceed the yield stress at the face of the column, while strain hardening develops at the critical section of the plastic hinge. A minimum distance equal to beam height,  $h_b$ , or 500 mm, whichever is less, is recommended [3]. Because the nature of shear transfer across the critical section of a plastic hinge is complicated, care must be taken with detailing of the shear reinforcement. As Figure 3 (b) indicates, the beam's shear force  $V_b$  introduced to region A by the diagonal forces has to be transferred to the top of the beam in region B. This necessitates stirrups extending between these two regions, perhaps supplemented by specially bent top beam bars, to carry the entire shear force.

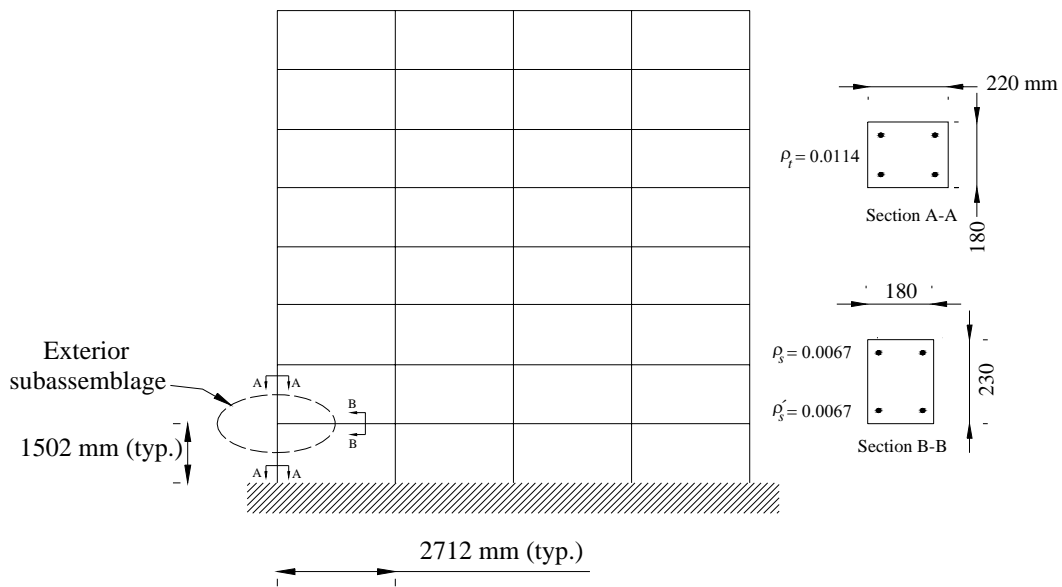
Figure 4. Scale down model of the selected frame.

Figure 4 shows a 1/2.2 scale of the selected frame. This scale was chosen as it allows the similitude requirements to be fulfilled as well as the model to fit in the testing frame. The member section sizes and reinforcement that were obtained based on this scale, satisfied the limitation of the hydraulic actuator size and the ultimate capacity of the hydraulic jacks. The prototype structure is a typical eight story residential RC building located in Brisbane, Australia. The controlling design criterion for this structure is the strength required to resist the applied gravity and lateral loads. The prototype was designed as an Ordinary Moment

An exterior beam-column sub-assembly was isolated at the first floor level of the scaled down frame as shown in Figure 4. Although the location of the points of contraflexure of the columns above and below a given story may vary when the frame is subjected to cyclic actions such as earthquake, a good estimate for the mean column shear force can be obtained if it is assumed that the points of contraflexure in all columns provided in a given storey occur approximately at mid-height. Figure 5 shows the deformed shape of a typical story of the selected frame. In this Figure,  $l$  is the span length and  $l_c$  is the story height. As is seen, the lateral load on this frame produces an interstorey drift of  $\Delta H$ .

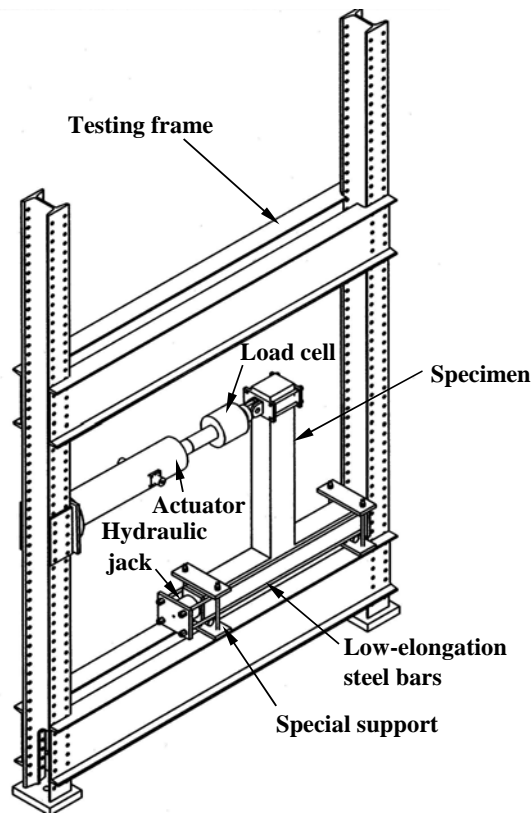
Figure 8. Test set-up

The testing rig was built up into a 3 m by 3 m rigid frame. Figure 8 shows the experimental set-up. The joint was rotated 90° so that the column was parallel and the beam was perpendicular to the ground. The free end of the beam was loaded and the connection between the beam and the actuator was carefully designed in order to ensure that the load could be applied in a push-pull manner. Axial loading of the column was simulated by stretching four high-strength low-elongation steel bars that were placed outside the column by the use of a hydraulic jack while a load cell was utilised to measure the applied load. The column were supported at each end with specially designed supports that ensured their ends were free to rotate but not to translate. This special hinge support was designed to simulate the real performance of the sub-assemblies at the inflection points as well as applying the constant load into the column.

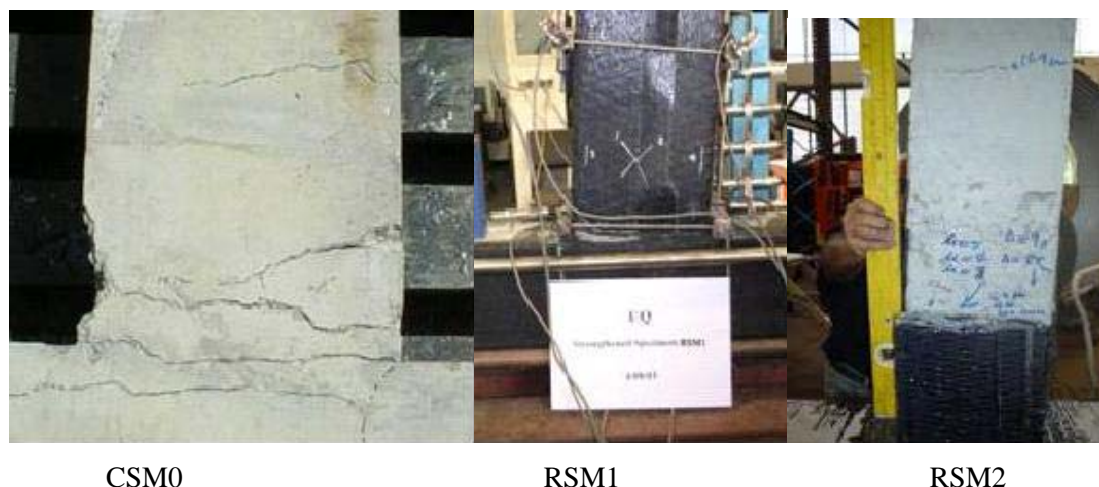
Figure 9. Ultimate failure of specimens CSM0, RSM1 and RSM2.

The plain control specimen was tested to failure in order to determine its capacity, flexural stiffness, and failure mode. This specimen was first loaded to initial yield under load control and then to failure under a displacement control regime. When the load corresponding to steel yielding level was reached in the experiments, flexural cracks were developed at the beam-end close to the column face and some flexural cracks were propagated into the joint core. This trend continued up to the end of the test whereas the beam flexural cracks at the column face opened and subsequently the load dropped and the beam collapsed (see Figure 9).

The retrofitted specimen RSM1 with only one CFRP sheet on the web exhibited a brittle failure. This specimen was tested under a similar loading regime as CSM0. Firstly, flexural cracks in the beam end became more obvious and then the top beam bars started to yield in tension at the column face and some bond deterioration was observed in the main beam bars around the beam end facing the column. At ultimate, concrete crushing occurred at the face of the column, which followed by the beam rotation about the fulcrum, and the rupture of CFRP on the tension side. Subsequently, major cracks were relocated from the cut-off of CFRP to the beam end at the column face. A loud crackling sound was heard at this stage indicating the initiation of concrete crushing and the subsequent rupture of CFRP. No shear cracks were observed in the beam end or within the joint region. Figure 9 shows specimen RSM1 at failure. Specimen RSM2 was tested under the same loading regime as RSM1. Firstly at the displacement ductility of 1, the flexural cracks at the cut-off point of the wrap became more obvious and then the top beam bars started to yield near the cut-off point of CFRP. These cracks became wider towards the failure point. Some shear deformations were occurred in the wrapped area. In general, this specimen exhibited a ductile failure. In this specimen, plastic hinges were relocated from the column face to the cut-off point of CFRP as shown in Figure 9.

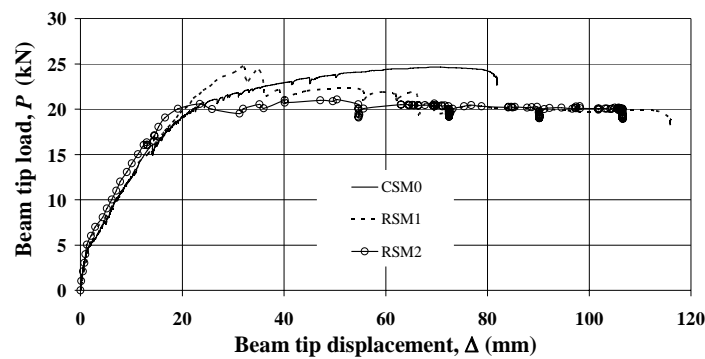
Figure 10. Beam's tip load vr. displacement for specimens, CSM0, RSM1 and RSM2.

The beam's tip load versus displacement curves for specimens CSM0, RSM1 and RSM2 are shown in Figure 10. Table 1 shows that the maximum strengths and the estimated ductility of all specimens are tabulated. As is seen the maximum load recorded in these tests were about 24.64, 24.70, and 21.12; for specimens CSM0, RSM1 and RSM2 all in kN respectively. As is shown, the maximum load strength recorded for specimen RSM1 is about that of the plain specimen CSM0 whereas that for specimen RSM2 is only 86% of the maximum strength of plain specimen CSM0. It may relate to the fact that the retrofitting length of this specimen was not sufficient enough to carry loads at the early stages of the test.

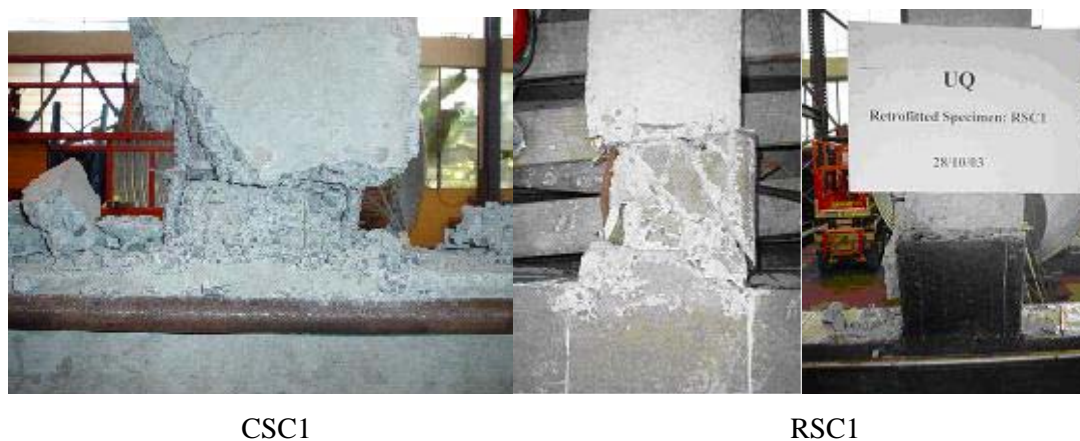
Figure 11. Failure pattern of specimens CSC1 and RSC1.

to the back of column due to the bond deterioration between the column top reinforcements and concrete. Cracking of the concrete due to the flexural deformation of the beam was initiated from the beam end at the column face and grew along the beam length. Some cracks were penetrated into the joint core at beam's tip displacement of 31.6 mm. Crushing and spalling of the concrete occurred in the thirteenth cycle at the tip displacement of 94.8 mm and the corresponding load of 19 kN (pull). This load was the maximum load that the specimen held. The specimen failed soon after when buckling of the beam's top rebar occurred at the column's face. Consequently the load on the specimen started to descend. The final failure pattern is shown in Figure 11. The plastic hinge was formed at the face of the column.

Figures 11 and 12 show the failure mechanisms and beam-tip load versus displacements of specimens CSC1 and RSC1 respectively and Table 1 contains the estimated displacement ductility factor for these specimens. As is seen, an almost similar displacement ductility were calculated for these specimens whereas the failure of specimen RSC1 is located further from the beam end and joint core indicating that the plastic hinge in this specimen is relocated from the joint core toward the beam under cyclic loading regime and therefore the performance of the frame is converted into a ductile manner.

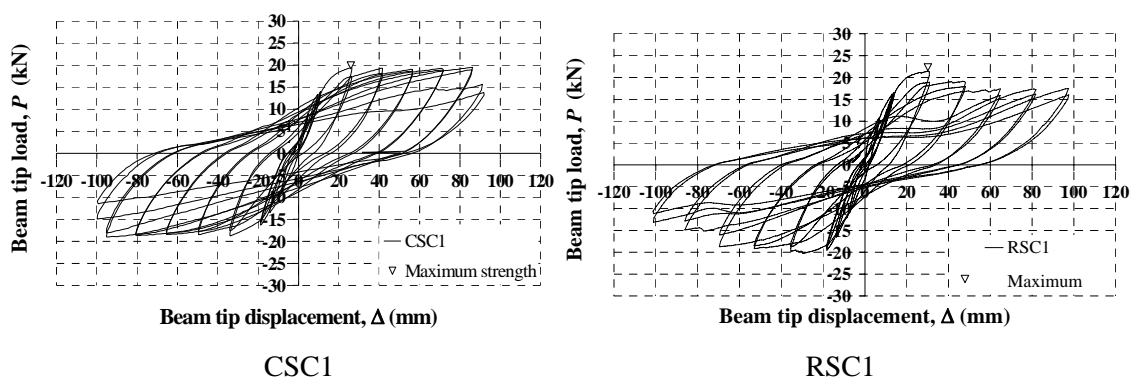
Figure 12. Load versus displacement for CSC1 and RSC1.

Examining the hysteretic behaviour of the specimen showed severe pinching, stiffness degradation during the test and strength deterioration in the final two cycles followed by spalling of the concrete and the subsequent full buckling of the steel reinforcements at the column face, as shown in Figure 12.
