VULNERABILITY ANALYSIS OF THE HISTORICAL BUILDINGS IN SEISMIC AREA BY A MULTILEVEL APPROACH

L. Binda^{*1}, G. Cardani¹, A. Saisi¹ and M.R. Valluzzi²

¹Department of Structural Engineering, Politecnico of Milan, Italy

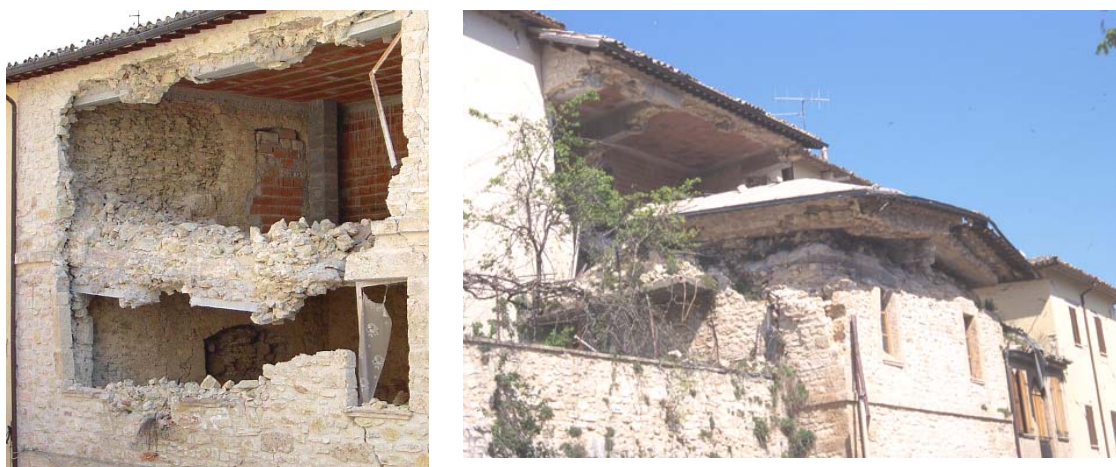
Figure 1. Example of a) Out-of-plane collapse of a wall with r.c. tie beams, b) roof hammering the masonry walls

regions, motivated the study. The damages showed as most retrofitting carried out after the previous 1979 earthquake, mainly performed with upgrading interventions (substitutions of timber floors and roofs with r.c., jacketing, etc.), caused unforeseen and serious out-of-plane effects (large collapses, local expulsions) (Figure 1), due to the “hybrid” behaviour activated from the new and the old structures [1], [2]. That effect was not clearly predictable by the existing assessment methods also suggested by the Italian as well as other seismic codes. The proposed analytical procedures were in fact based on hypotheses often not easy to be satisfied in old historic stone masonry buildings, as the effective strong connection among the structural components and the presence of stiff floors, both characterising the favourable “box” behaviour of buildings under seismic actions. It was also clear that the main cause of inappropriate choice for the intervention techniques was due to the lack of knowledge on the existing materials and on the structural behaviour due to the peculiar type of construction techniques used in the past centuries for the historic buildings.
