Technical Note

**EXPERIMENTAL STUDY ON REHABILITATION OF RC BEAMS
USING EPOXY RESINS**

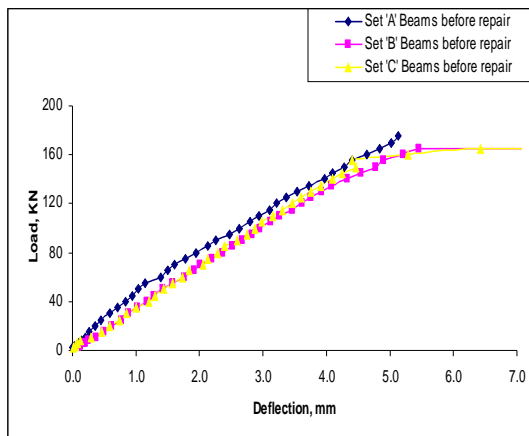
Figure 1. Load-deflection relationships for set 'A', 'B' & 'C' beams before repair

Figures show the Load-Deflection curves at mid span section for R.C.C. beams specimens before and after repair. The elastic deflections at initial stage of loading for beams after repair are found to be small when compared to beams before repair. The same trend follows even at final stage of loading in the plastic state, though the deflections are greater at the middle-state of loading. In the load-deflection curve for beams, a linear behavior continues initially, till the first crack produces a district change in slope. The change in slope of curve is accentuated by the incidence of further cracks till the yielding of reinforcement starts. The curve is, however, horizontal at high loads for beams after repair. The final deflections for members after repair were found small compared to the members before repair. Figure show the variation of compressive and tensile strains with load along the depth of section at one-third span and mid span for beam specimens before and after repair respectively. Both compressive and tensile strains follow a linear relation even at high loads for beams after repair. Tensile strains were small in beam members after repair. The compressive and tensile strains were linearly progressive along the depth of section.

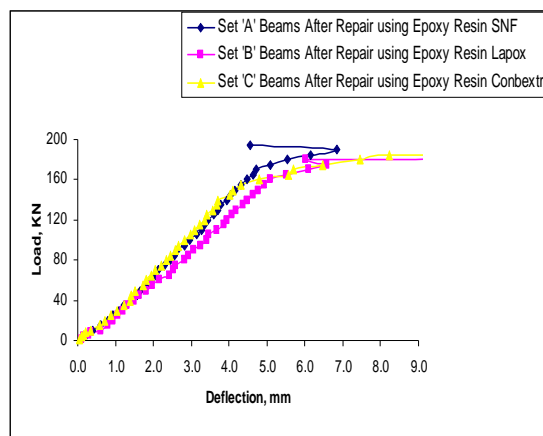
Figure 2. Load-deflection relationships for set 'A', 'B' & 'C' beams after repair

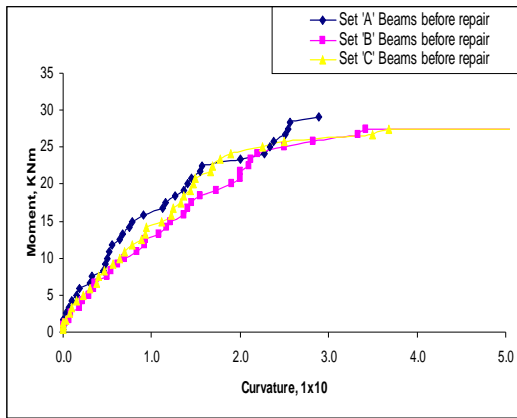
Figure 3. Moment-curvature relationships for set 'A', 'B' & 'C' before repair

Figure ure show the moment-curvature relations at one third span and mid span for beams before and after repair, respectively. Both the curves for the beams before and after repair will follow a bi-linear relation with change in slope at the moment of first crack. The curvature varies linearly with moment in all stages of loading, also in the plastic state except change of slope that occurs at the moment of first crack and the moment at first yield of reinforcement. The curvatures are low for beams after repair compared to before repair. The ultimate crushing load at failure is high for beams after repair compared to beams before repair. The crack patterns in R.C.C beams before and after repair are shown in Figure. The maximum crack widths for beams before and after repair are appeared at mid span. The maximum crack widths for beams before repair were observed as 1.2mm. The flexural shear cracks began at mid span at a minimum load of 6 kN and propagated vertically up to the neutral axis. A maximum crack width of 1.2mm appeared at 90% ultimate load in beams before repair and a maximum crack width of 1.3mm appeared at ultimate crushing load of 180 kN at mid span. Web shear cracks began from middle-third span and propagated diagonally towards the centre of span up to the neutral axis. The average crack width is 0.20mm and the maximum deflection was occurred at mid span at ultimate crushing load of 180 kN for beams after repair. All the graphical representations are presented in Figures 1-4.

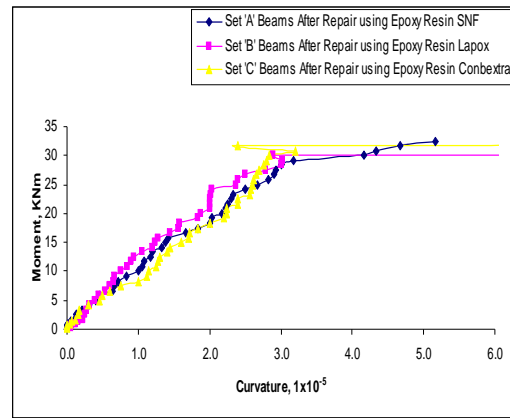
Figure 4. Moment-curvature relationships for set 'A', 'B' & 'C' after repair

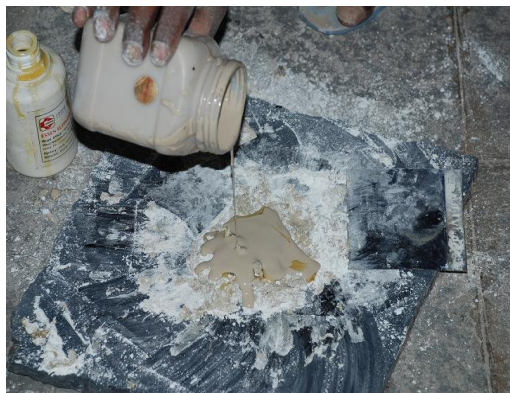
Plate 1. Mixing ESSEN base and hardener to fill groove and fix the PVC pipes

The distressed beams removed from the testing machine are first chased the cracks to form a 'V' shaped groove as shown in the plate. Then water is sprinkled on prepared groove to remove the loose particles. Then the process of putting is done. The mixture of ESSEN SNE base and the ESSEN SNE hardener are mixed thoroughly and filled in the groove and then PVC nozzle pipes of 8mm diameter are fixed in the cracks and placed at a distance of 50mm to 100mm as shown in the plate and injected into the pipes with the hand blown pressure as shown in the plate. Then the pipes are tied with the wire as shown in the plate. The pipes are cutted down smoothly up to the level of the beam surface as shown in the plate after 24 hours.

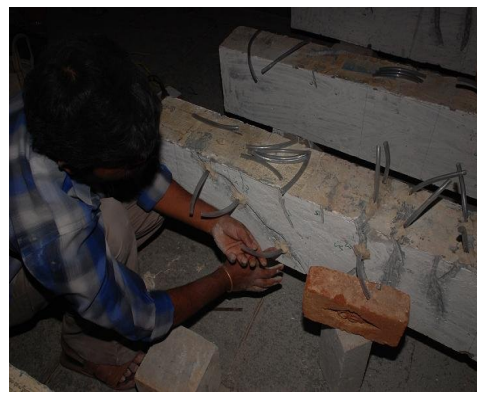
Plate 2. Fixing the PVC pipes into the grooves

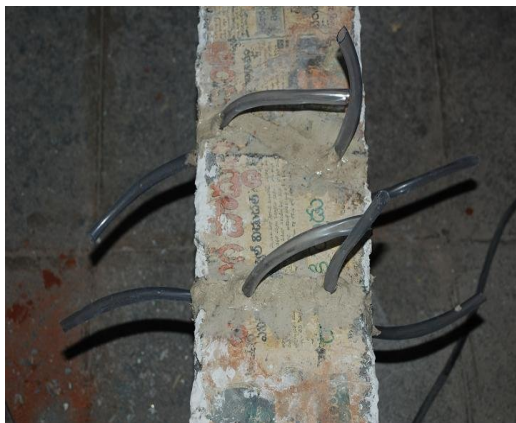
Plate 3. Fixed the PVC pipes into the grooves

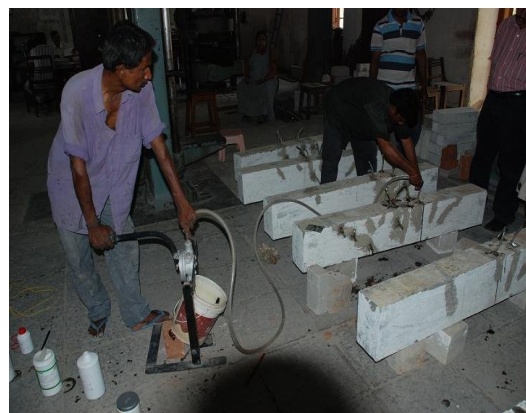
Plate 4. Injecting the epoxy resins into pipes

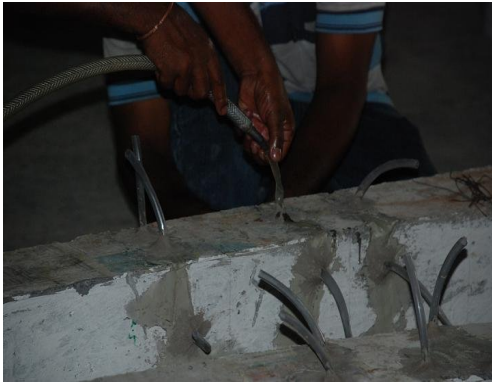
Plate 5. Injecting the epoxy resins into pipes

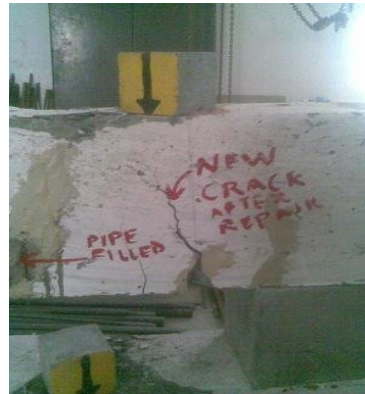
Plate 6. Beams after test

Plate 7. Beams after test
