## UNEXPECTED EXPANSION OF CONCRETE MADE WITH LAUMONTITE CONTAINING AGGREGATES UNDER SEAWATER CONDITION

### ABSTRACT

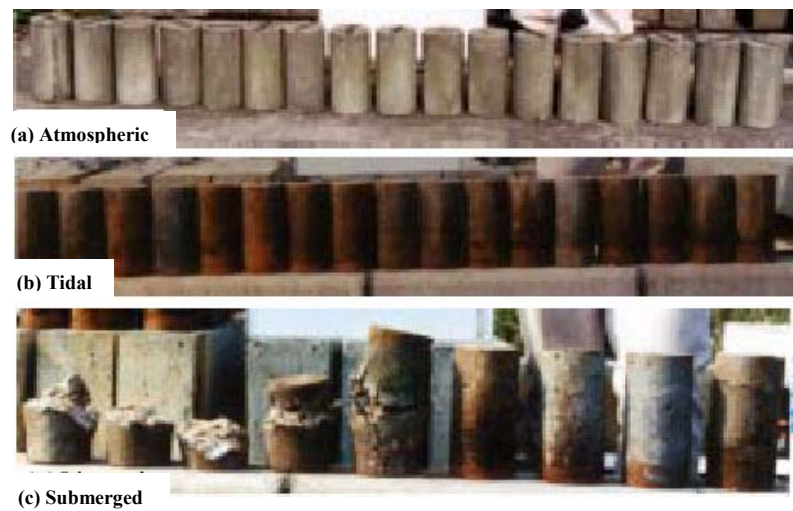
Figure 2. Appearance of some specimens (at 15 years of exposure)

Cracking over the specimens was identified after 5~6 years for tidal and submerged specimens. Appearance of the specimens at 15 years of exposure is shown in Figure 2. The specimens exposed to the atmospheric exposure show minute hair cracking without any advance stage of deterioration. In the tidal exposure, the extent of deterioration is varied from severe cracking on the specimens to the moderate cracking. In the submerged zone, the extent of deterioration is varied from complete disintegration of the specimens to the

moderate cracking. Lateral expansion as well as distortion of the specimens was clearly found for some specimens. The submerged specimens were deteriorated very quickly compared to the tidal specimens. At 30 years of exposure, some specimens of the tidal exposure showed severe lateral expansion. Some tidal specimens showed moderate deterioration. Interestingly, no significant deterioration was visualized for atmospheric exposure. The above-mentioned observations indicate that deterioration of the specimens strongly influenced by the type of marine exposure; severe for submerged exposure, moderate for tidal exposure, and no significant influence for atmospheric exposure.

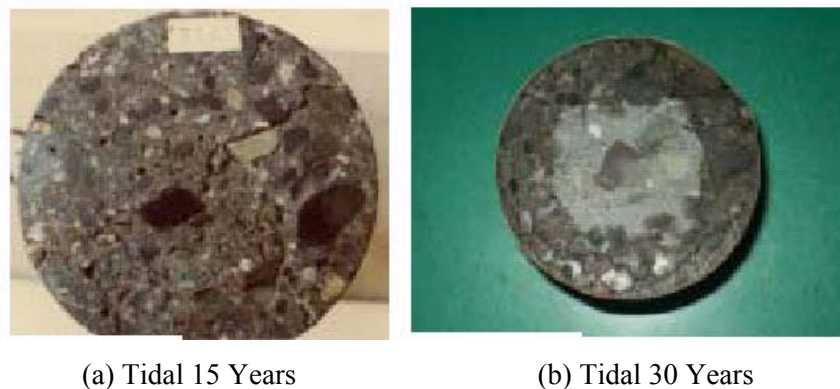
Figure 3. Transverse section of the tidal specimens

The cut surfaces of the specimens are shown in Figure 3. Severe cracking in the specimens is observed due to the expansion of aggregates with the presence of seawater at

15 and 30 years of exposure. Cracking in concrete is not necessarily uniform around the specimens (Figure 3, Left). It is due to the variation of the distribution of reactive aggregates in the specimens. The mortar portion of the deteriorated region becomes relatively softer but not necessarily porous due to the deposition of the new products, such as ettringite, calcite, brucite, etc. in the pore structures. The results related to this deposits are explained later. White deposit around the aggregate at the deteriorated region was clearly observed. The deposit was confirmed as ettringite based on the SEM investigation. The central portion of the specimens remains as normal concrete. Condition of the fractured surface after spraying phenolphthalein solution is shown in Figure 4. The deteriorated region surrounding the specimens is carbonated. No carbonation was found for atmospheric specimens even after 30 years of exposure due to the rich mixture proportion with  $W/C=0.37$  (Table 2).

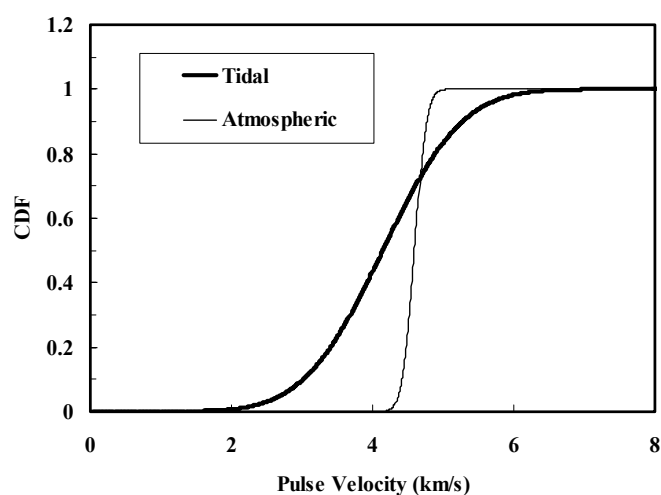
Figure 5. CDF of the pulse velocity data

The remaining specimens of the tidal and atmospheric zones were tested for pulse velity at the age of 30 years. Some of them were crushed to evaluate the compressive strength. Compressive strength of concrete varies widely for tidal exposure. The cumulative distribution function of pulse velity obtained from normal distribution is shown in Figure 5. The key statistical parameters are summarized in Table 4. The variation of the data for atmospheric specimens is very low. In atmospheric exposure, the average strength loss of the specimens was about 17% compared to the 28-day strength. Contrary, in tidal exposure, the pulse velity varies in a wide range from 2.1 km/s to 5.09 km/s; 10% of the data show a strength value less than 4 MPa, 50% of the data about 17 MPa, and 90% of the data below 52 MPa. The variation of the data in the case of tidal exposure is expected due to the variation in content of reactive aggregate in a specimen. It is important to note that pulse velity was converted to strength value based on the established numerical relations for tidal and atmospheric exposure (from known strength and velity data). The strength and pulsevelity data clearly indicate that the deterioration of the specimens was strongly

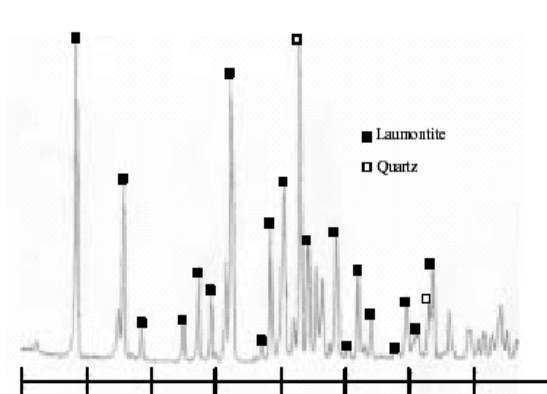
Figure 6. The XRD Chart of the aggregates

The XRD chart of the aggregates (after making powder) collected from the severely deteriorated region of the specimens after 15 years of exposure is shown in Figure 6. Peaks for laumontite mineral are clearly found. The SEM micrographs of the fractured region of the aggregates are shown in Figure 7. Bands of laumontite minerals are clearly identified in the aggregates.

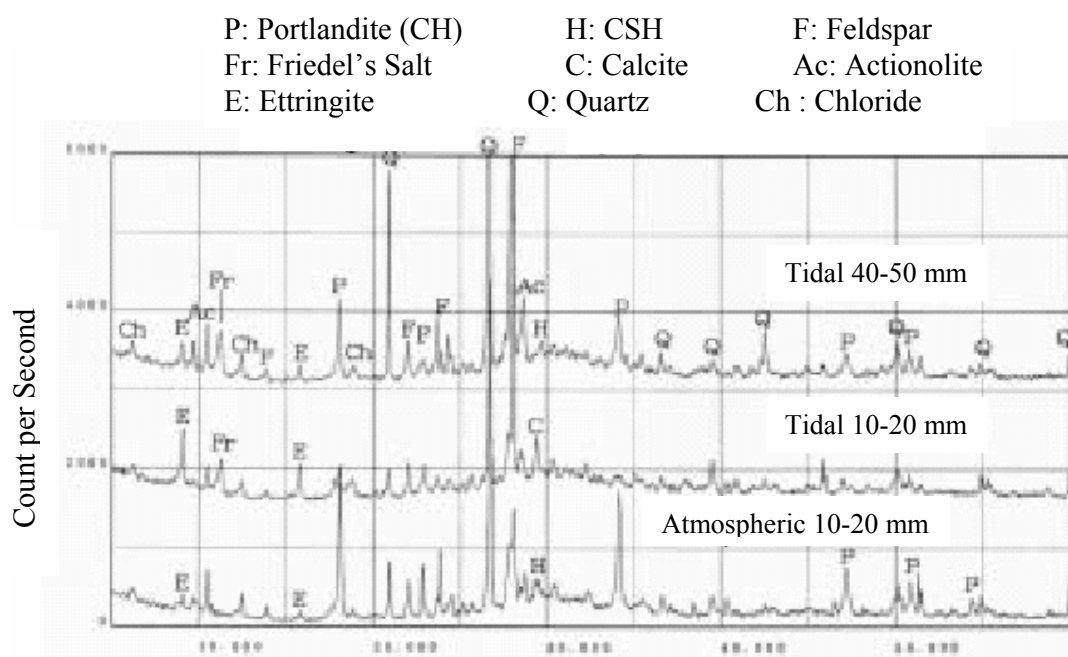
Figure 8. XRD charts of mortar (30 years of exposure)

The XRD charts of the mortar portion of concrete at the center (40~50 mm) and outer (10~20 mm) regions of the atmospheric and tidal specimens after 30 years of exposure are shown in Figure 8. It is found that the peaks of CH at the outer region of the tidal specimens

are very low compared to the inner region of the tidal specimens or the outer region of the atmospheric specimens. Calcium carbonate is observed at the outer region of the tidal specimens indicating carbonation of concrete at the outer region (Figure 4). Peaks for ettringite are also clearly observed at the outer region. CSH was not identified at the outer region of the specimens exposed to the tidal exposure. The presence of gypsum crystals was not found. Peaks for brucite were not detected in the samples tested at 30 years of exposure, however were clearly detected in the samples tested at 15 and 27 years of exposure. The presence of brucite was also found in SEM investigations at 15, 27 and 30 years of exposure.

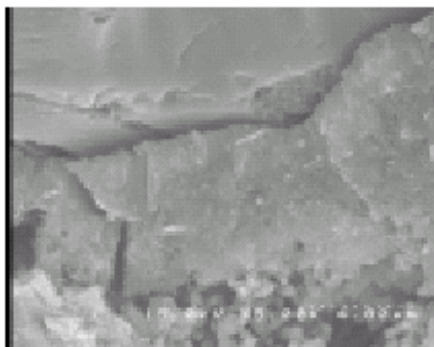
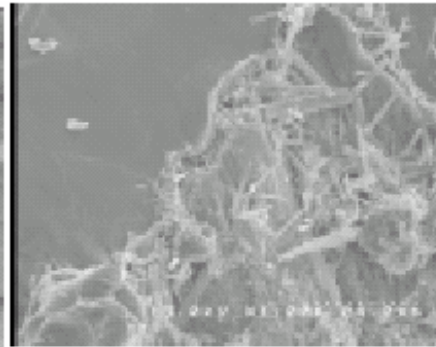
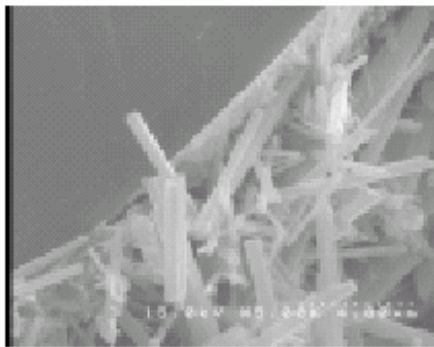
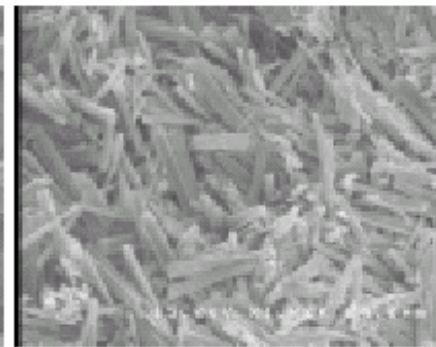
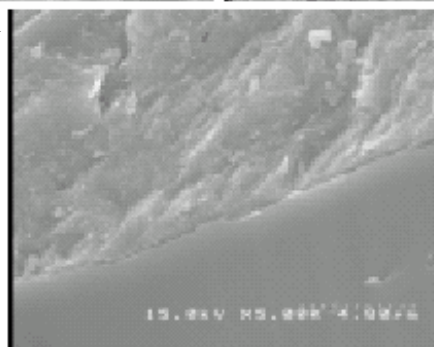
Figure 9. Aggregate-matrix interfaces (30 years exposure)

Count Per Second Aggregate-matrix interfaces are shown in Figure 9 for the atmospheric and tidal specimens. Densely populated ettringite crystals were found at the aggregate-matrix interface at the outer region of the tidal specimens (b)-(d). No significant amount of ettringite was found at the interfaces at the inner region of the tidal specimens as well as the outer region of the atmospheric specimens (a) and (e). White deposit was clearly found surrounding the aggregates. The deposits were confirmed as ettringite (d). The aggregates at the outer region of the tidal specimens lost its adhesion with matrix due to the deposition of ettringite surrounding the aggregate.
