CRACKING IN PRECAST, PRESTRESSED DECK PLANKS IN TWO RTA BRIDGES: CAUSES OF CRACKING, CONCRETE CHARACTERISTICS AND REHABILITATION OPTIONS

*A. Shayan

ARRB Transport Research Ltd, Victoria, Australia. Howard Morris, Bridge Durability and
Maintenance, Roads and Traffic Authority of NSW, New South Wales

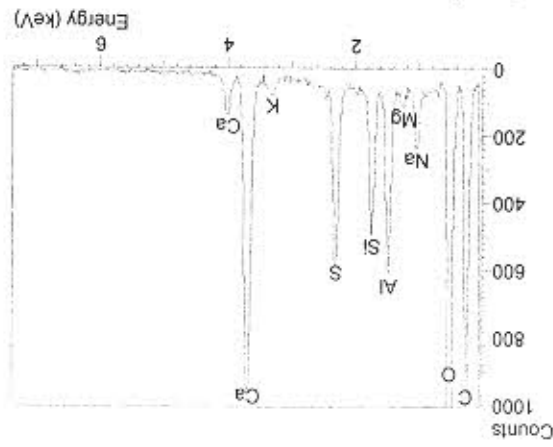
Cores B3 and B4 from the uncracked PSC plank of BC bridge were free of both AAR product and secondary ettringite. The hydrated cement paste in the bulk concrete and at the aggregate interfaces was low in alkali and silica, and rich in Ca, compared to the AAR products shown earlier. Although the aggregate types in the two PSC planks are the same, the cement type in the plank represented by cores B3 and B4 must have been different, and probably low in alkali for AAR not to have occurred.
