## EVALUATION OF PERFORMANCE OF RETROFITTED REINFORCED CONCRETE BEAM COLUMN JOINTS– A SIMPLIFIED MODEL

### ABSTRACT

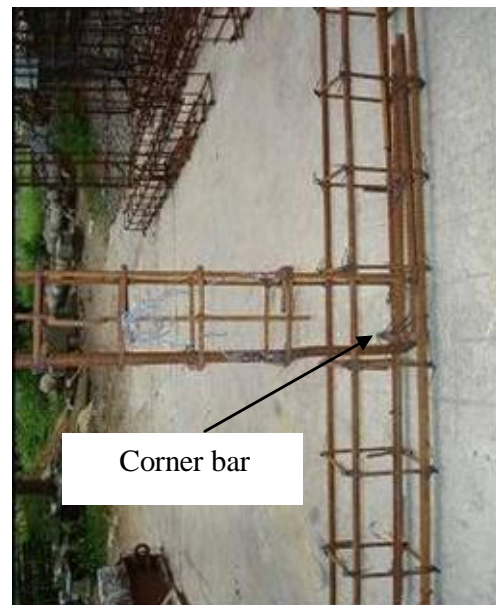
Figure 2. View of reinforcement grills with corner bars

The experimental program consisted of testing four RC beam-column joint specimens. The columns had a cross section of 200 mm x 200 mm with an overall length of 2100 mm and the beams had a cross section of 200 mm x 200 mm with a length of 750 mm. The concrete mix was designed for a target strength of 40 MPa at the age of 28 days. The longitudinal reinforcement of the square columns was kept constant for all the RC beam-column joint specimens and consisted of 4 numbers of 12mm diameter (HYSD) bars having an yield strength of 500 MPa. The spacing of 6mm dia mild steel stirrups in columns was 200 mm c/c as per IS 456:2000 [18] as required by the gravity design (Figure 1). In the beam portion, main reinforcement consisted of two numbers of 16mm HSD bars. Two numbers of 10mm dia HSD bars provided as stirrup hangers also perform as compression reinforcement. The stirrup spacing in the beams was 150mm c/c. In addition to the above, a corner bar of 16mm dia was provided in the column portion as shown in Figure 2.

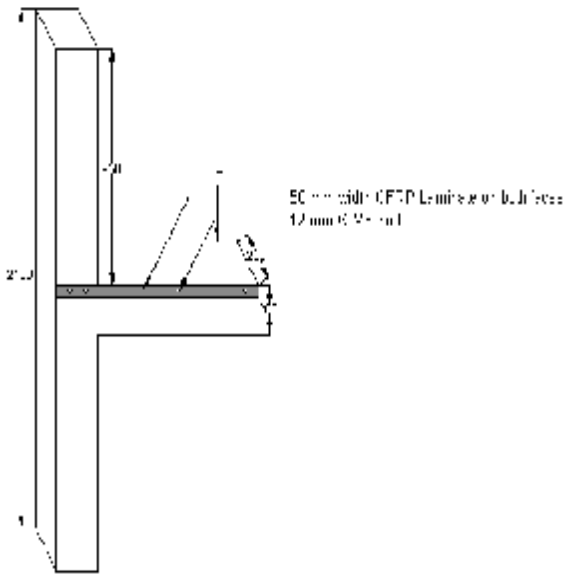
Figure 3. CFRP laminates in the top face of the beam

In method –1, the beam-column specimen is strengthened with CFRP laminates on the top face of the beam as shown in Figure 3. The sides of the beam at top were ground to a width of 50mm and to a depth of 3mm using a grinding machine. The grounded surface was thoroughly cleaned to be free from dirt, oil and grease. One coat of primer was applied on the ground surface for effective bond between laminate and concrete. The 50 mm wide CFRP laminate was cleaned with acetone and three holes of 12 mm diameter was drilled for fixing the laminate into the concrete surface. The saturant was then applied over the surface of the beam and laminate face. The CFRP laminates was bonded on the beam surface and allowed to cure for seven days. Three 12mm dia bolts were also fixed using epoxy to increase mechanical anchorage of CFRP laminate.

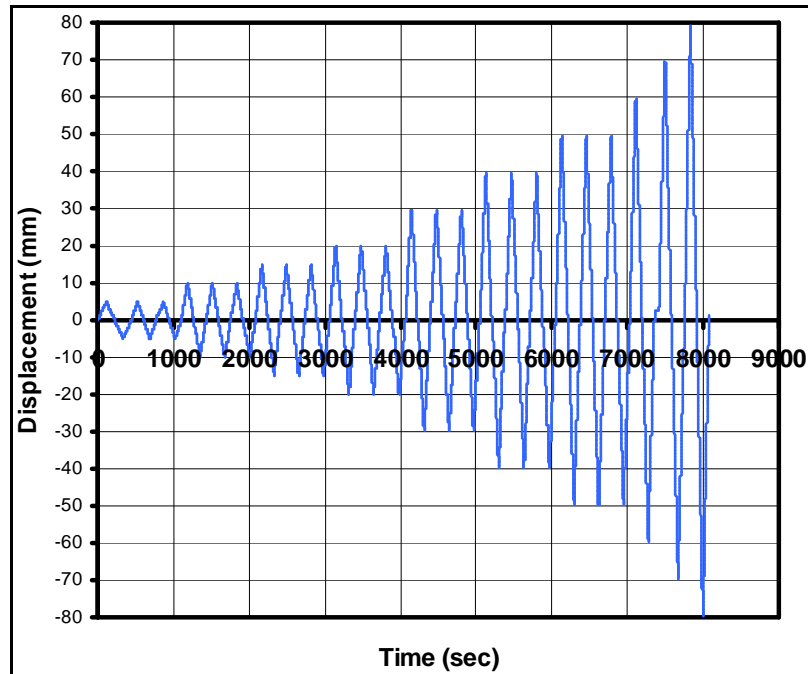
Figure 8. Typical time vs displacement plot for different strengthening schemes

Details of the typical Time vs Displacement plot for different strengthening schemes are given in Figure 8. The load deflection plots for the retrofitted beam column joints using the various methodologies are given in Figure 9.

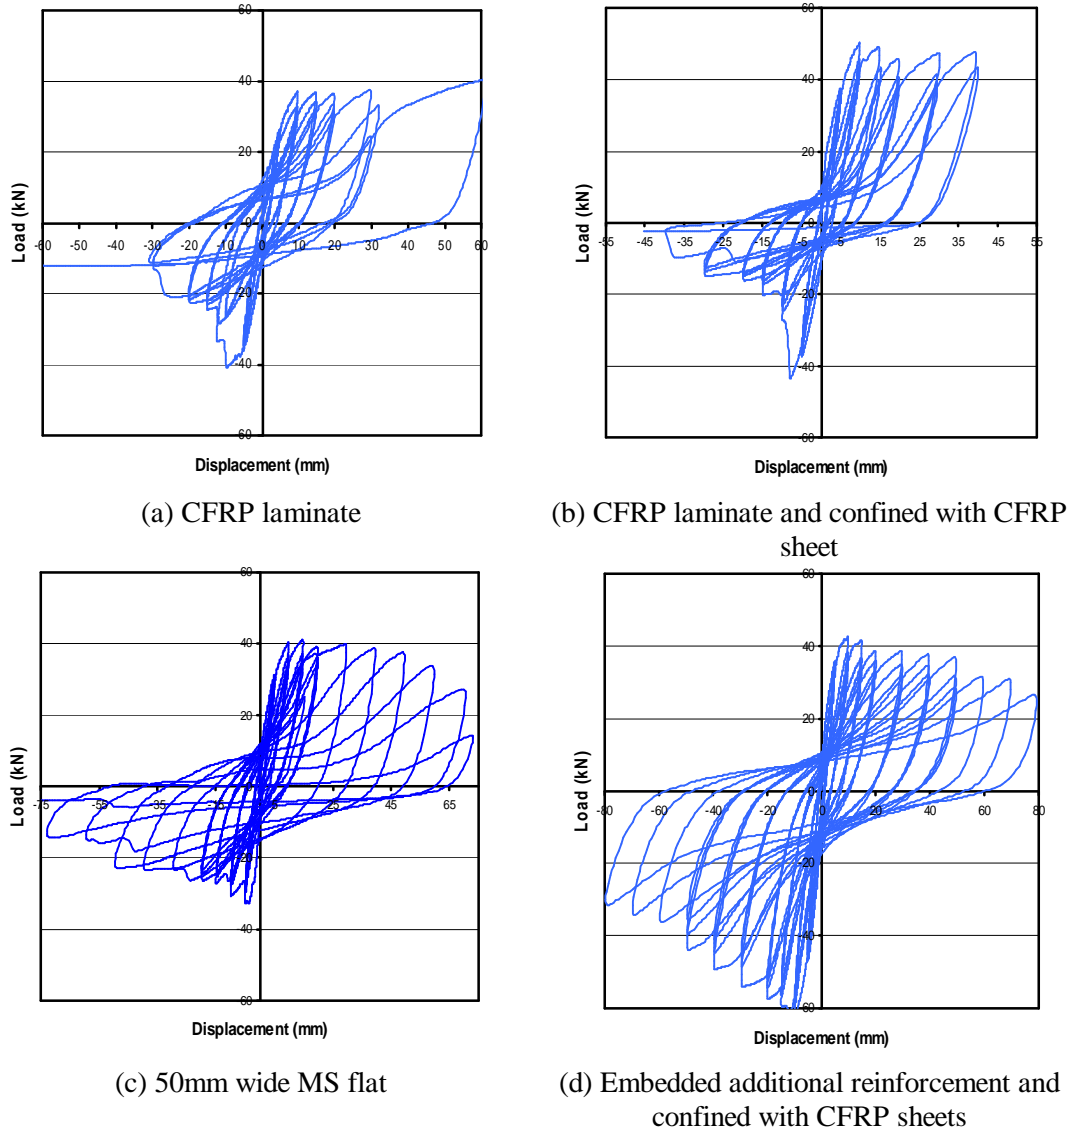
Figure 9. Cyclic behaviour of beam-column joints

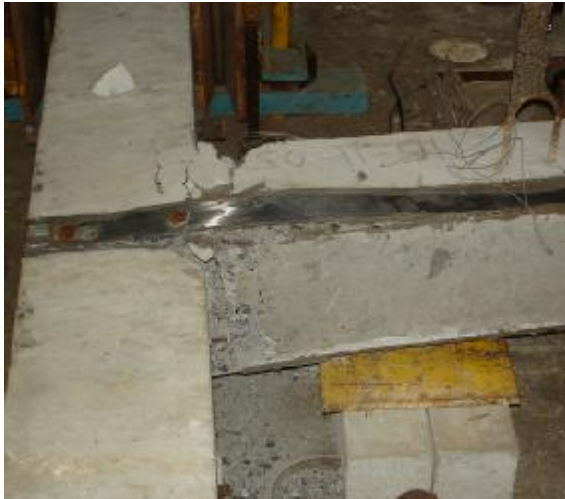
(a) CFRP laminate

Figure 10. Failure pattern of various strengthened beam column joints

In the case of the repair Method 1, the strengthening was carried out in the top face of the beam using CFRP laminate. During the test, the cyclic response in the tension and compression faces showed significant improvement upto a displacement of 20 mm. Beyond 20 mm, the repaired face showed extensive cracking in the laminate portion and further enhancement of the load was not achieved. After this stage, the joint was loaded only on the bottom face till failure. The primary mode of failure was debonding of the FRP strips in the joint region as shown in Figure 10a. The 12mm bolt meant for anchoring also pulled out near the inner edge of the column due to crushing of concrete in that region. Beyond this stage, the joint was loaded only from bottom till failure as shown in Figure 10(a). The beam failed around 60mm upward displacement.

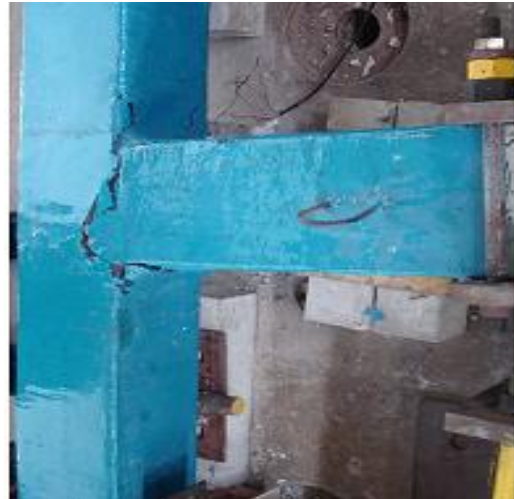
(b) CFRP laminate and confined with CFRP sheet

In the case of the repair Method 2, the strengthening has been carried out using CFRP laminate in the top face of the beam and further confining the junction with CFRP sheets. During the reversed cyclic loading, it was observed that confining the joint with CFRP did not result in significant improvement in the load carrying capacity of the joint. Beyond 30 mm, the top face showed extensive spalling of concrete in the laminate portion and further enhancement of the load was not achieved. Concrete spalling was also observed at the beam-column joint on the face of the column as well. The column wrap which secured the ends of

the FRP strip prevented the strip from completely debonding; however, the column wrap was not effective in preventing localised debonding in the joint region. The final crack pattern in the joint region is shown in Figure 10b.

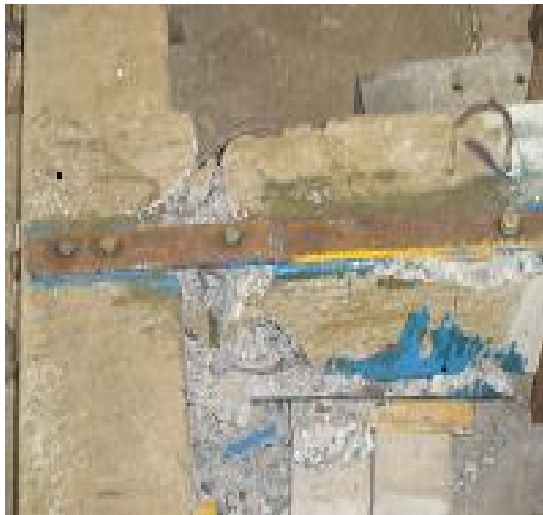
(c) 50mm wide MS flat

In the case of the repair Method 3, the strengthening has been carried out using MS flat section in the top face of the beam. Even though the load carrying capacity of the joint was marginally lower compared to methods 1 and 2, the ductility of the joint was improved as seen from Figure 9c. After reaching 50mm displacement, only one load cycle was carried out with incremental amplitude being 10mm. Beyond 70 mm displacement cycle, the plate reinforcement in the joint could not sustain the loading as the concrete has completely spalled leading to loosening of the anchor bolts. The ductility

of the joint was significantly improved with the provision of the MS flat compared to the earlier two methods and the retrofit methodology adopted was better. The failure pattern of beam column joint is shown in Figure 10c.

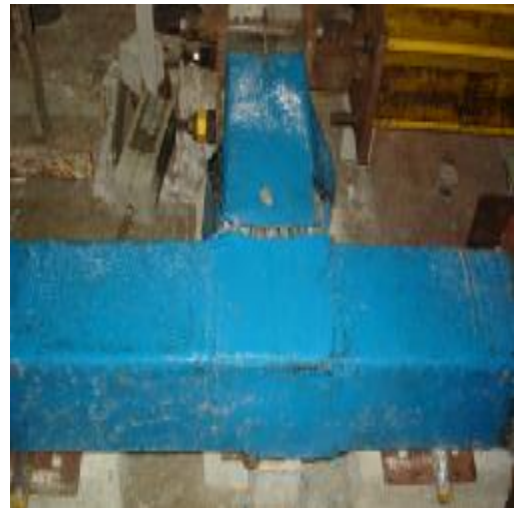
(d) Embedded additional reinforcement and confined with CFRP sheets

The strengthening has been carried out using additional reinforcement in the top region of the beam in Method 4. In addition to the additional reinforcement, CFRP sheets were wrapped in the joint region for further confinement. There was a sharp increase in the load carrying capacity, ductility and energy absorption capacity of the joint compared to other three methodologies adopted. Concrete crushing was also observed at the beam-column joint on the

compression face of the column. The column FRP wraps secured the additional reinforcement completely in position even after the failure of joint/non shrink grout. The column wraps were effective in confinement of the joint region. The final failure pattern in the joint region is shown in Figure 10d. After reaching 50mm displacement, only one load cycle was carried out with incremental amplitude of 10mm. The joint did not fail even after achieving a displacement level of 80 mm and continued to carry 40% of the peak load. This retrofitting methodology shows significant improvement in the load carrying capacity and overall performance.

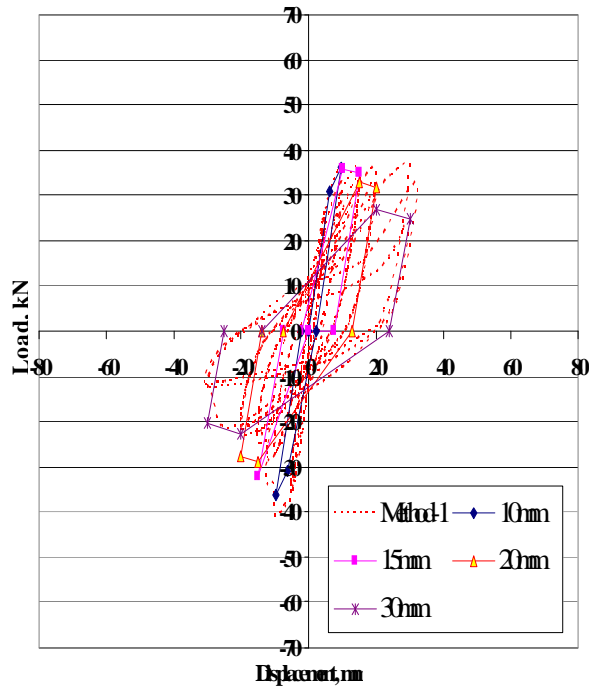
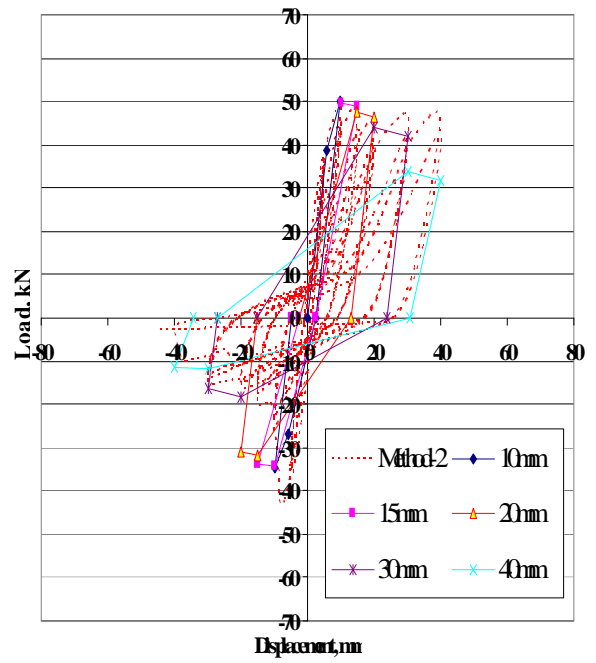
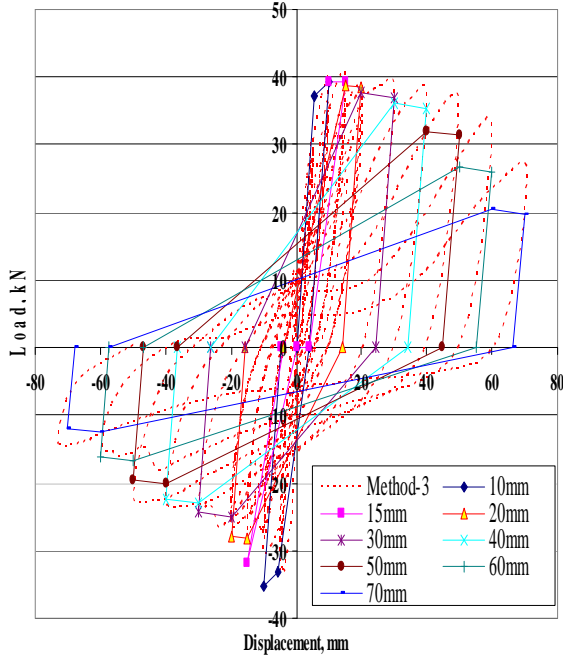
(a) CFRP laminate

(b) CFRP laminate and confined with CFRP sheet

(c) 50mm wide MS flat

(d) Embedded additional reinforcement and confined with CFRP sheets

Figure 14. Load-deflection response for cyclically loaded various strengthening schemes

While the initial stiffness in all the models were more or less constant, the values of  $\alpha_s$  and  $\alpha_c$  have been chosen as given in Table 1. The yield load taken as corresponding to a deflection of 5mm varied in the range of 38 to 39 kN for specimens 2, 3 and 4, and was only 32kN for specimen-1. The cyclic deterioration factor  $c$  is assumed as 1.3. The analytical prediction of the hysteresis loop was obtained by trial and error method by varying the  $\gamma$ , which is used in the calculation of  $E_t$ , the reference hysteretic energy dissipation capacity ( $E_t = \gamma F_y \delta_y$ ). The hysteretic energy capacity is exhausted and collapse is assumed to take place when,  $\beta_i$  is outside limits ( $\beta_i \leq 0$  or  $\beta_i > 1$ ). The last hysteresis curve is the failure cycle, from which the failure deflection can be evaluated. Typical experimental and predicted load deflection plots are given in Figures 14.

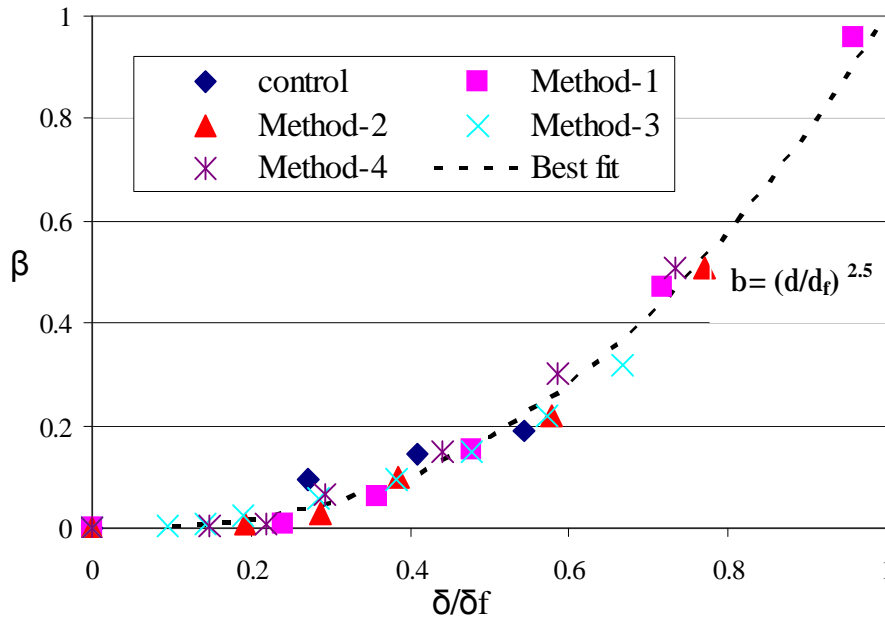
Figure 16. Variation of beta values with  $(\delta/\delta_f)$

The performance parameters are given in Table 2. The values of  $C_{p1}$  and  $C_{p2}$  are very close in all the cases indicating that the normalized profile of  $\beta$  variation with  $(\delta/\delta_f)$  may be a constant. Figure 15 shows the non-dimensional plot of  $\beta$  vs  $(\delta/\delta_f)$  for all specimens, and they are very similar. Expressing  $\beta = (\delta/\delta_f)^n$  the value of  $n$  is obtained as 2.5 as shown in Figure16. Thus the ratio of failure deformation between the retrofitted specimen and the control specimen for cyclic loading defines a unique performance parameter. This is exactly similar to the concept of ductility enhancement under monotonic loading, which can be used as performance parameter.
